Toby Inlet

Waterway Management Plan

May 2019

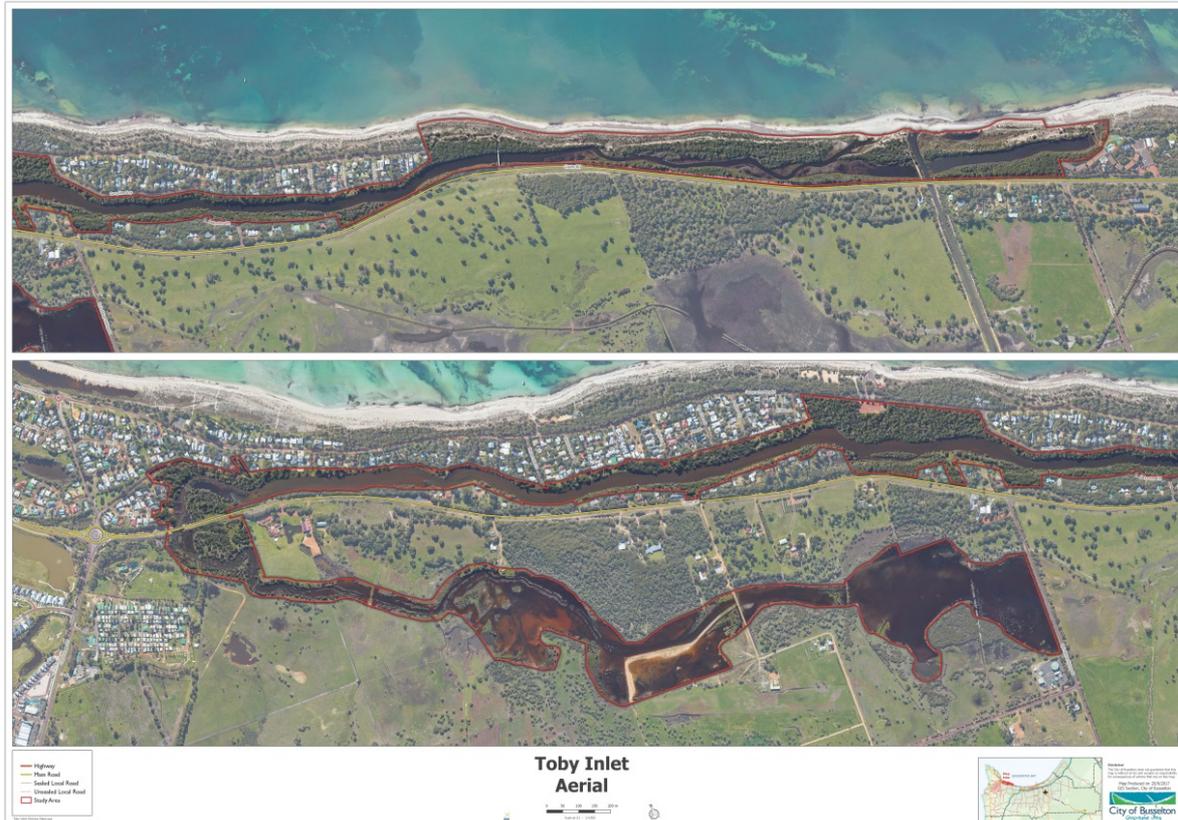
Figure 2. Toby Inlet locality and study area, and routine monitoring sites.

Toby Inlet is intermittently connected to the ocean, either naturally or artificially, at two points: via a channel to the east of Station Gully; and via a culvert to Station Gully, which then flows to the ocean. The connection of Toby Inlet to the ocean is likely to have always been intermittent, but it is thought that reduced flows from the catchment have decreased natural breaching of the sand bar.

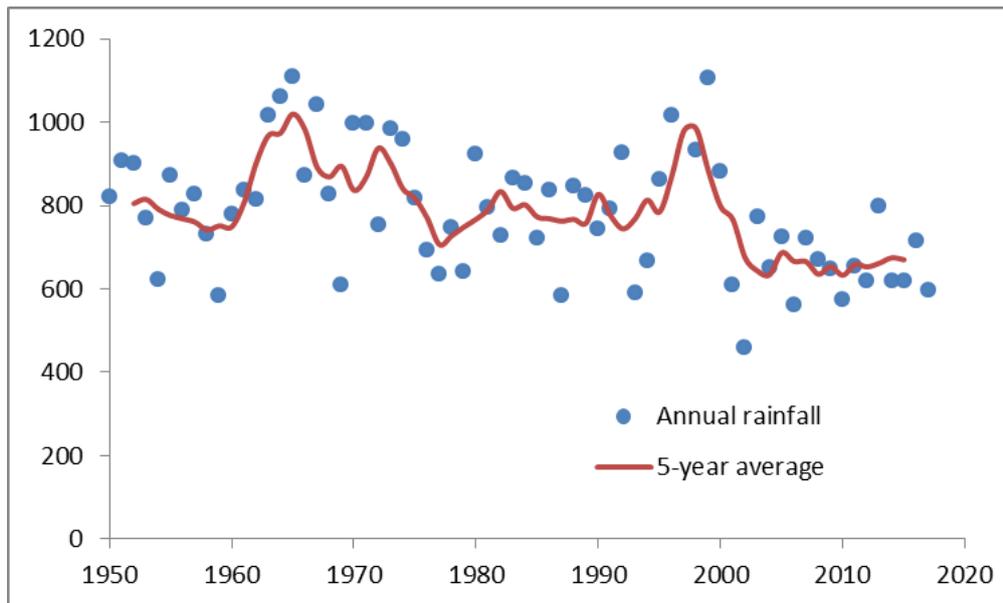
Figure 3. Rainfall records for Cape Naturaliste (BoM 2018). The 5-year average for each year includes two years before and after.

catchment is 651mm (10-year average, BoM 2018), with declining rainfall evident over the last 20 years (Figure 3).

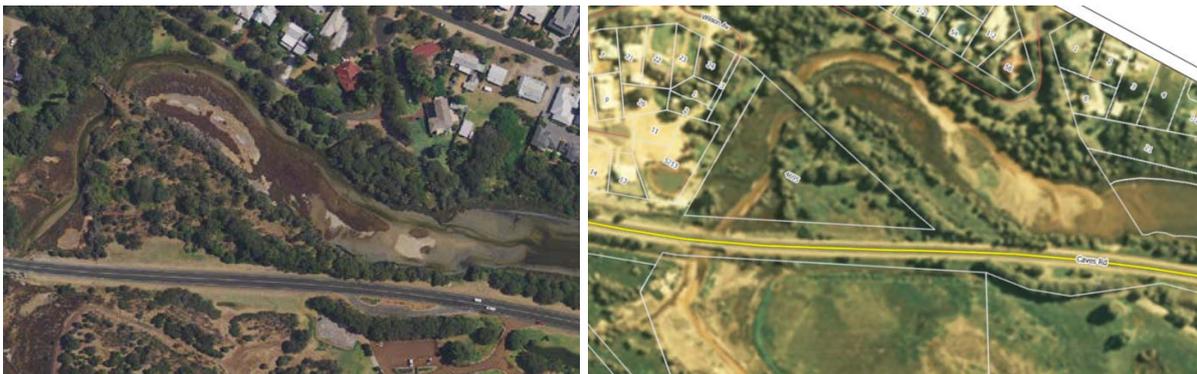
Figure 7. Comparative aerial photographs of sediment deposition in Toby Inlet downstream of Caves Road, from 2018 (left) and 1997 (right).

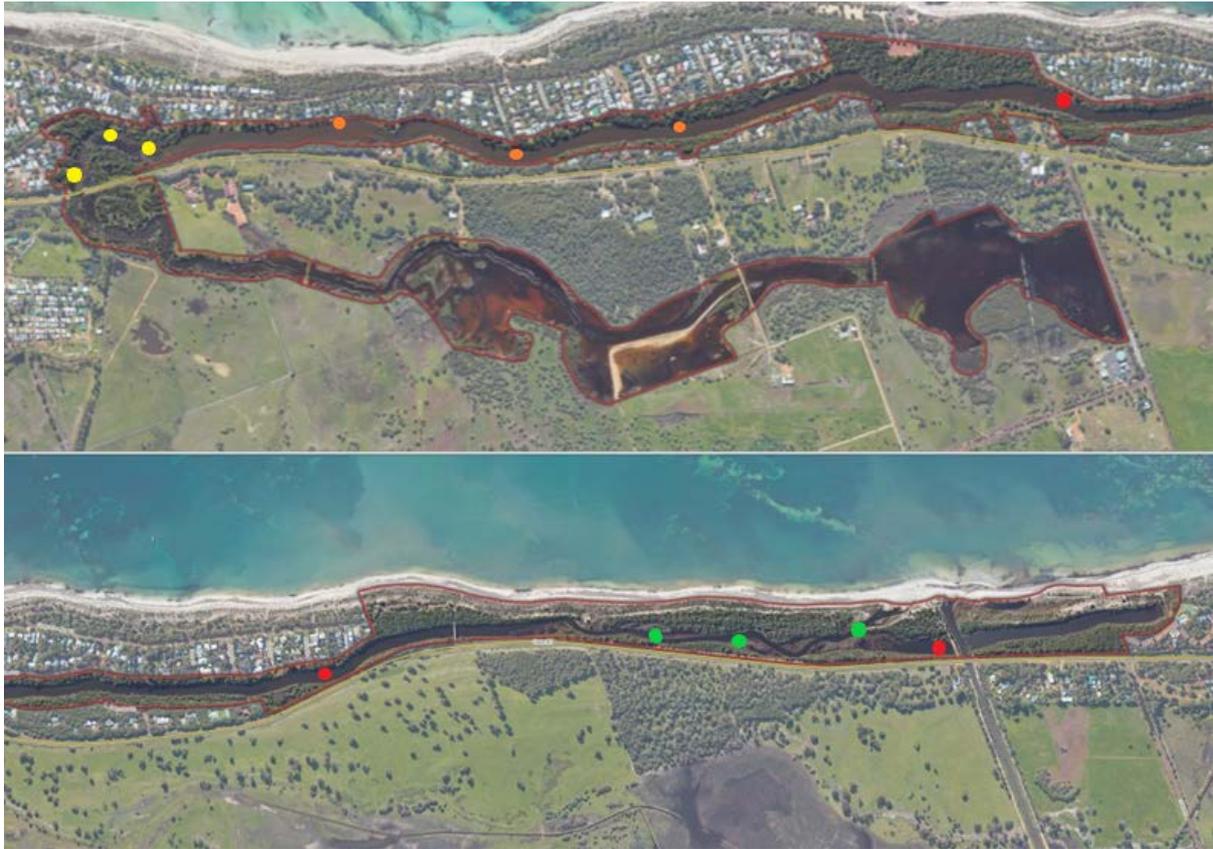
Figure 8. Acid sulphate soil and monosulfidic black ooze (MBO) presence in Toby Inlet sediments. Yellow markers show sand-dominated sediments with potential acid sulphate soils but no MBOs found in 2007 study. Orange sites show MBOs and potential acid sulphate soils in 2007 study. Green sites show no potential acidity or MBOs found in 2009 study. Red sites show MBOs and potential acid sulphate soils in 2009 study.

In downstream sections of Toby Inlet, accumulation of organic material has contributed significantly to sedimentation. Monosulfidic black ooze (MBO) has been found in the lower reach of Toby Inlet, from a point approximately 700m downstream of Caves Road Bridge (ENV 2007, Ward et al. 2009; Figure 8). MBO commonly forms in areas of high primary productivity, where seasonal growth and decomposition of algae results in accumulation of soft organic material with high concentrations of iron monosulfides (Ward et al. 2009). Growth of phytoplankton and filamentous macroalgae in Toby Inlet has been enhanced by increased nutrient loads from the catchment. MBO presents a risk of rapid acidification when disturbed, causing deoxygenation. Analysis of these sediments did indicate high potential for acidification, but also found that acid neutralising capacity (ANC) may be sufficient to buffer this effect (Ward et al. 2009).

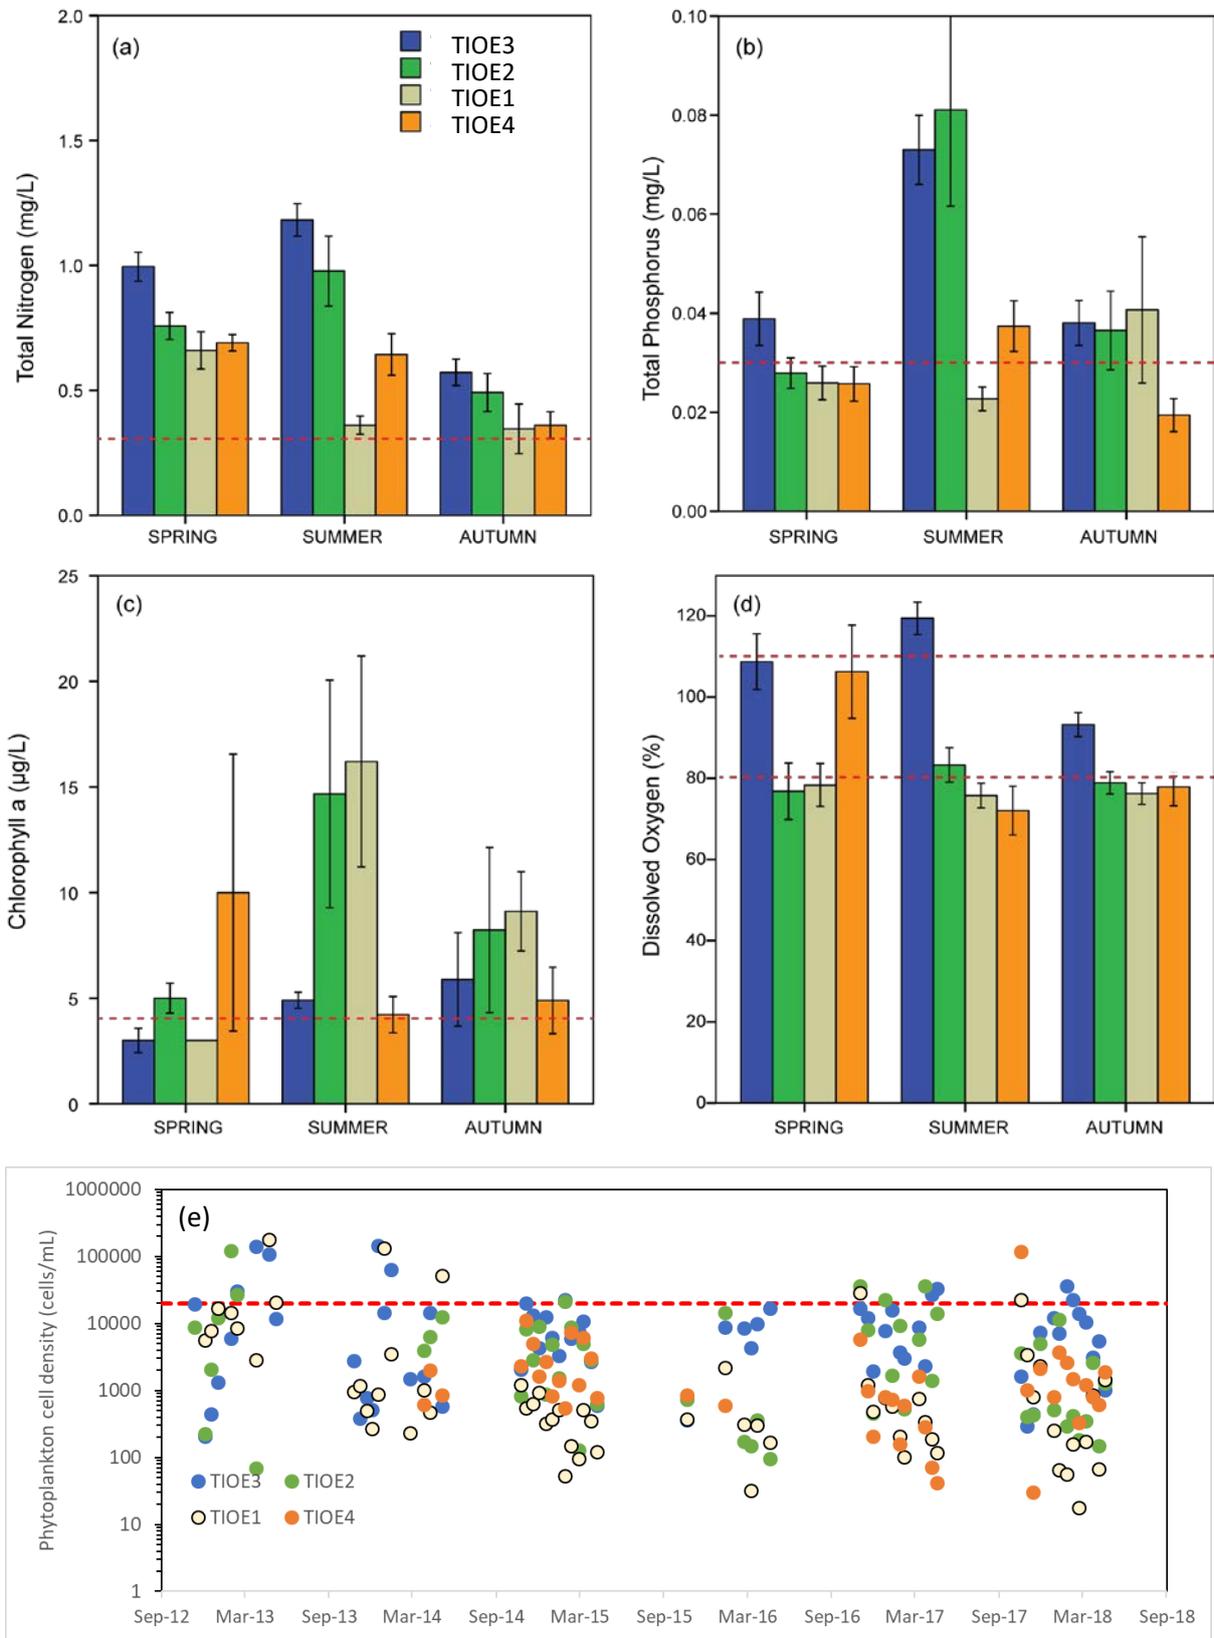
Figure 9. Average concentrations of water quality indicators (a-d) and phytoplankton density (e) in Toby Inlet (data courtesy DWER (DWER 2018)). Sites TIOE3, 2 and 1 are located east to west respectively from Quindalup Siding Road to the ocean exchange and TIOE4 is just near the culvert exchange with Station Gully, as shown in Figure 1. Red dashed lines are guideline values for protection of estuarine ecosystems (a-d) and recreational use (e) (ANZECC and ARMCANZ 2000). Note logarithmic scale in (e). Error bars are +/- standard error.

While nutrient concentrations appeared higher in the most upstream site, phytoplankton growth is greater lower in the Inlet (indicated by chlorophyll a, Figure 9c). Many types of phytoplankton are harmless, but at high densities can have unpleasant odours and form unsightly scums. Some species are toxic to humans and animals, including fish. Phytoplankton sampling by DWER since 2012 shows that the levels in Toby Inlet are mostly below the recreational guideline of 20,000 cells/mL (Figure 9e). However, harmful algal species have been found frequently at low densities. Blooms of blue-green algae have been detected twice since 2012.

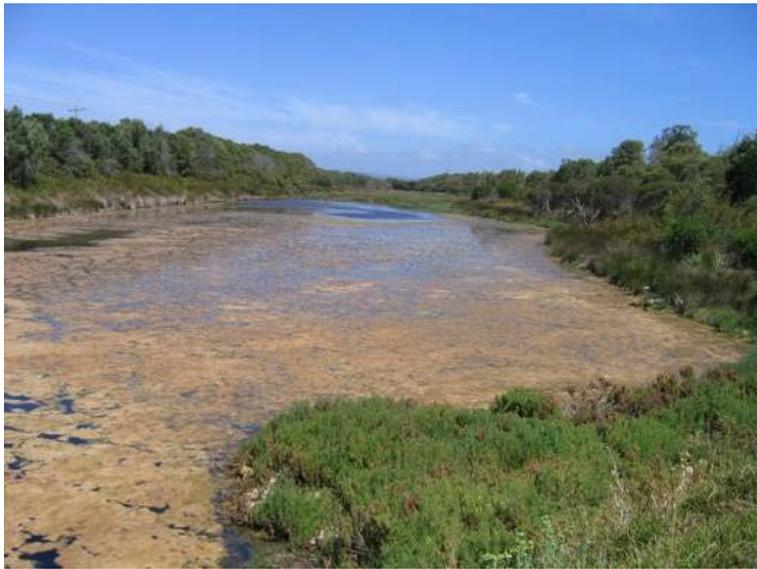
Figure 10. Macroalgae growing in Toby Inlet (DoW 2010).

Macroalgal blooms are currently more problematic than phytoplankton in Toby Inlet (Figure 10). They are not toxic but are unsightly and can cover large areas of water, restricting access and impacting visual amenity. Macroalgae also provides ideal habitat for breeding of nuisance midges. When large blooms of macroalgae decompose, this reduces oxygen levels in the water and sediments. Accumulation of this material has contributed to the formation of sulfidic sediments, including MBO. Although excessive growth of macroalgae is a serious management concern, no assessment or monitoring of species or biomass has been undertaken.

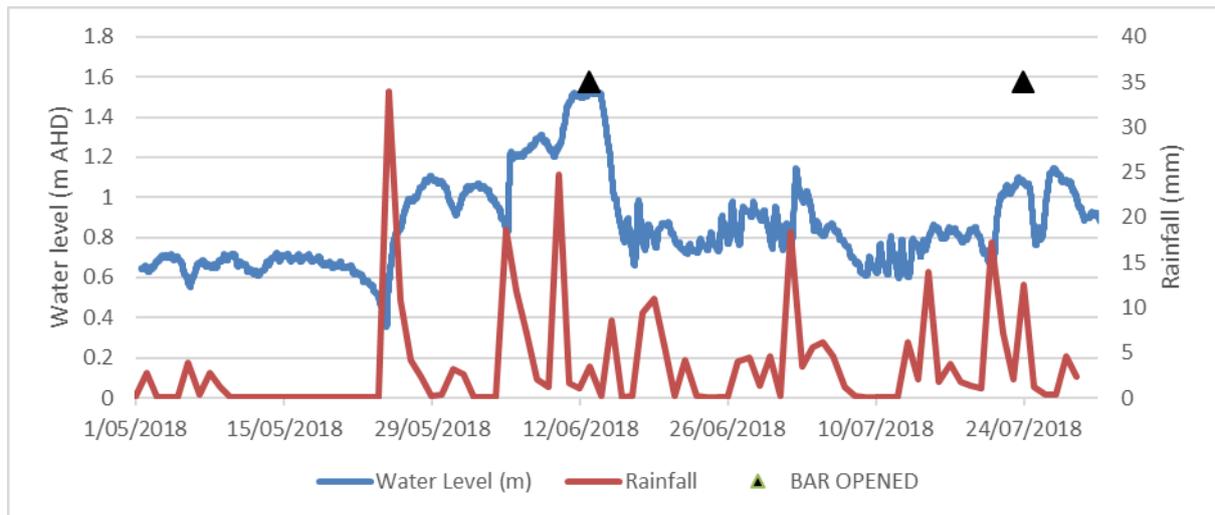
Figure 11. Water levels (blue line) at the Toby Inlet ocean outlet, daily rainfall (red line) and times when sand bar was opened (black markers) during May, June and July 2018. Rainfall data from BoM (2018).

Maintaining the ocean outlet throughout winter may incur excessive costs if it closes frequently. An appropriate trigger level would direct works only when there is a risk of flooding, and coincide with sufficient flows to maintain the opening. Given the flooding observed when water levels were at 1.5m, and the lack of a consistent channel when opened at around 1.1m, an appropriate trigger level would be at a height between these levels.

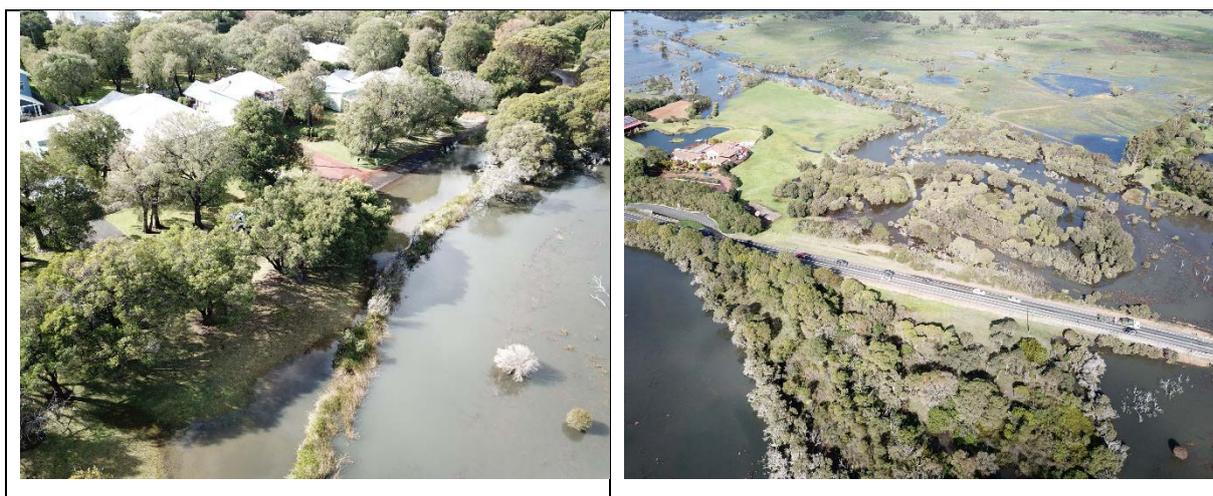
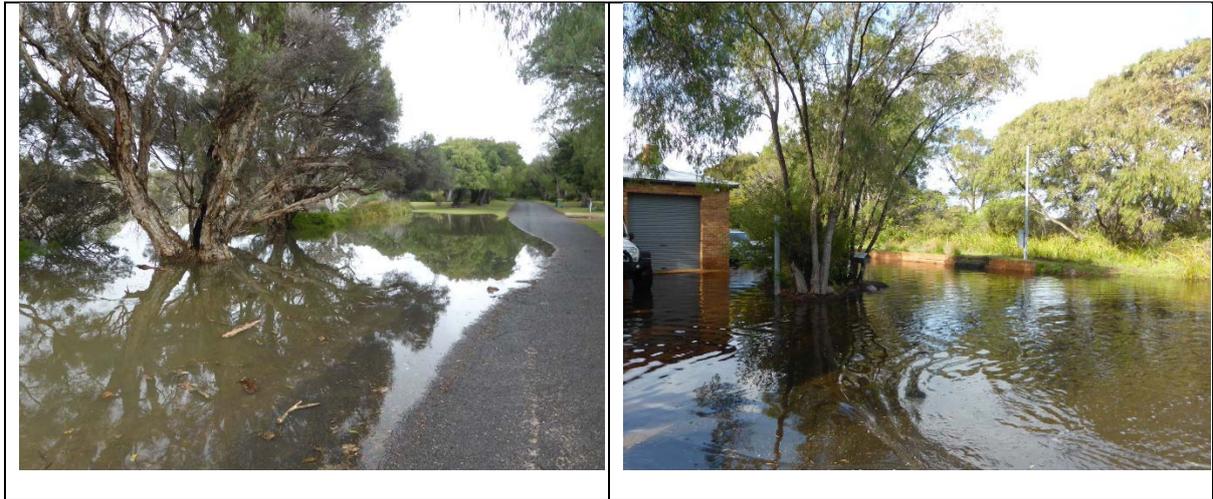
Figure 12. Photos showing minor flooding in the vicinity of Toby Inlet from 11th - 13th June 2018.

during this time show minor flooding in adjacent lands at these water levels (Figure 12). The sand bar was opened on 13th June 2018, lowering water levels to about 0.8m within two days. This opening was effective, and the outlet remained open intermittently for about four weeks. Rising water levels initiated further opening of the sand bar on 24th July when water levels were around 1.1m. In this instance the sand bar closed within two days.

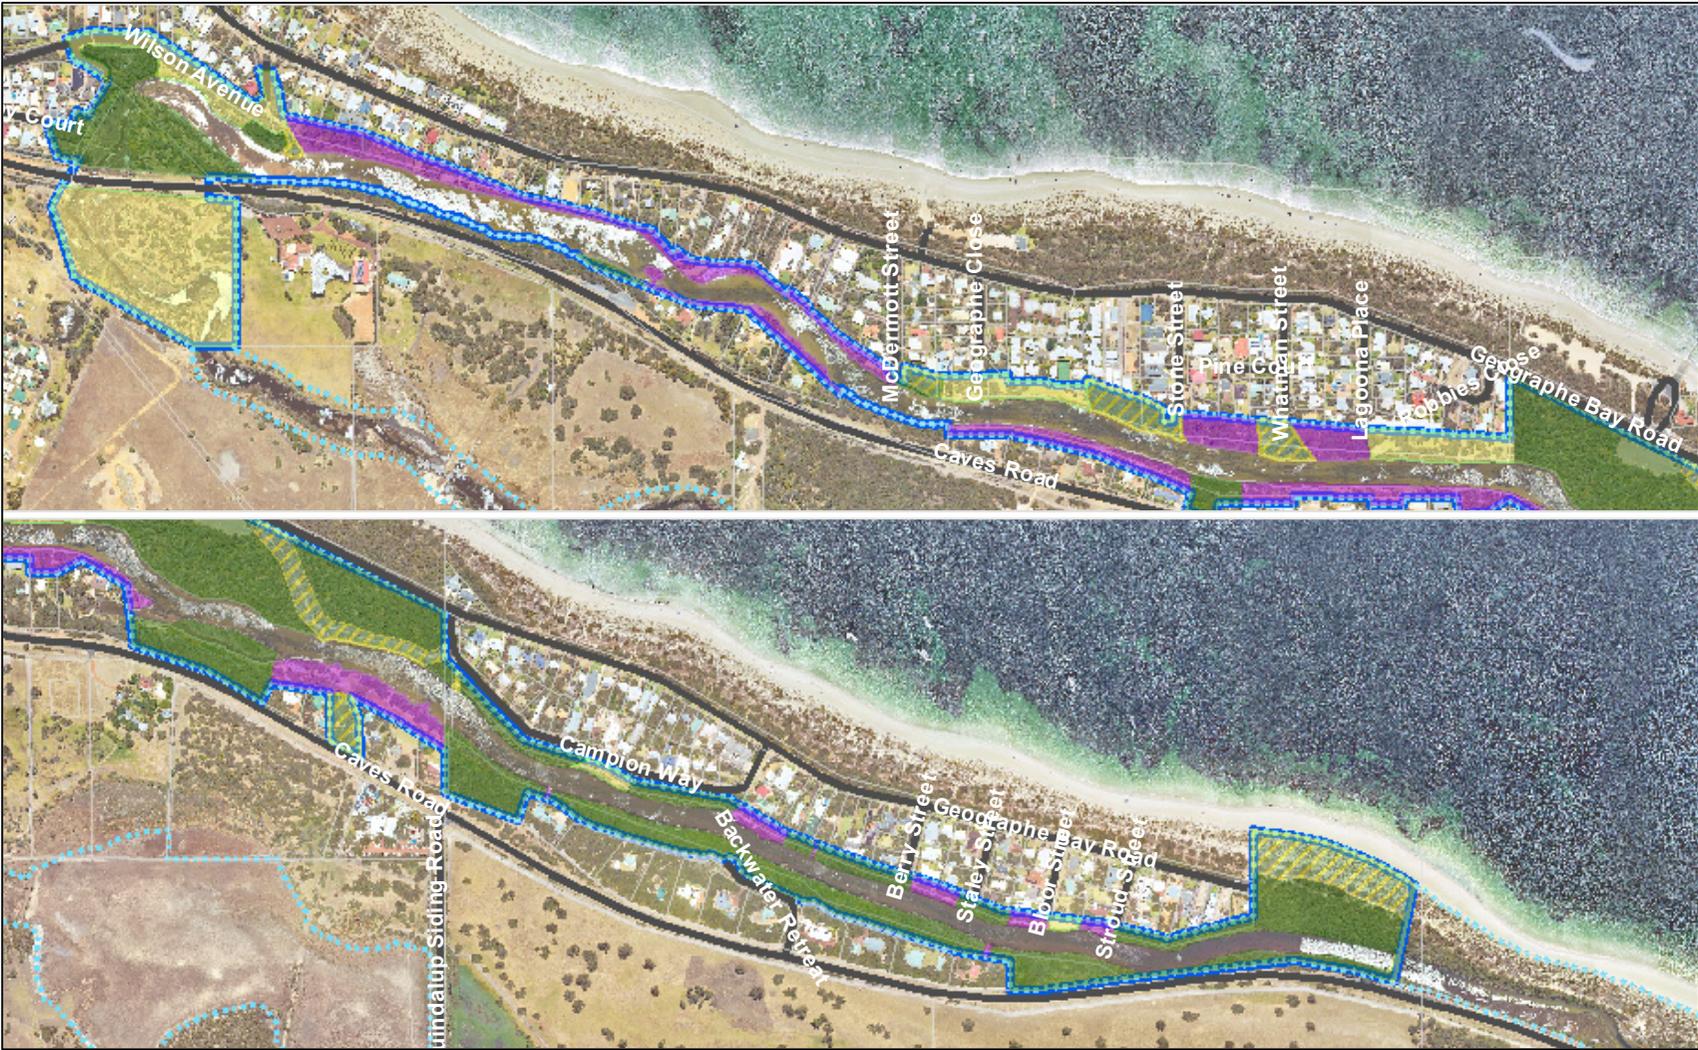
Figure 3-1 Toby Inlet access management precincts

These are mapped in Figure 3-1 (detailed in Appendix A) and are described below. Additional location specific recommendations, such as track closures and revegetation opportunities are also made in the Appendix.

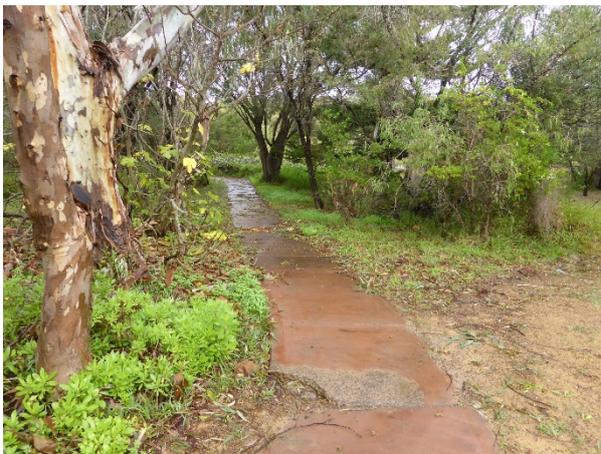
Figure 3-2 Existing path south of Geographe Close needing repair.

With the exception of the Geographe Bay foreshore walk and footbridge east of Geographe Bay Road, most of these tracks are in need of maintenance or could be improved with either a 1.2m (or City standard) red hot mix seal in the high traffic areas or those at risk of flooding (e.g. foreshore areas), or compacted limestone along the firebreaks. Formalising tracks would encourage use and contain potential impacts that might otherwise occur (e.g. minimise trampling along the edges). Some existing areas need to be repaired (e.g. existing concrete path south of Geographe Close, shown in Figure 3-2). Location specific management recommendations are provided in Appendix A.

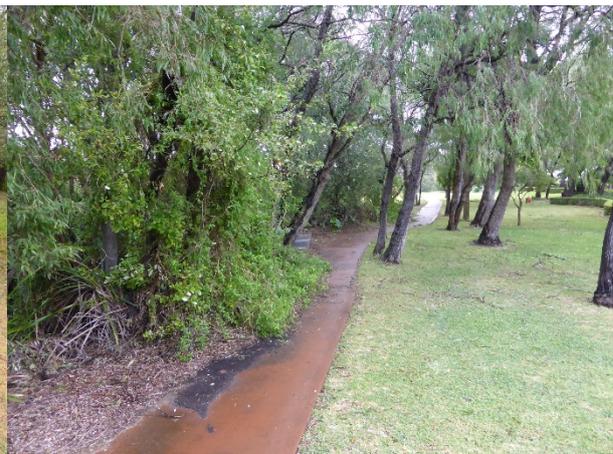
Figure 3-3 Existing path near Stone Street requiring maintenance.

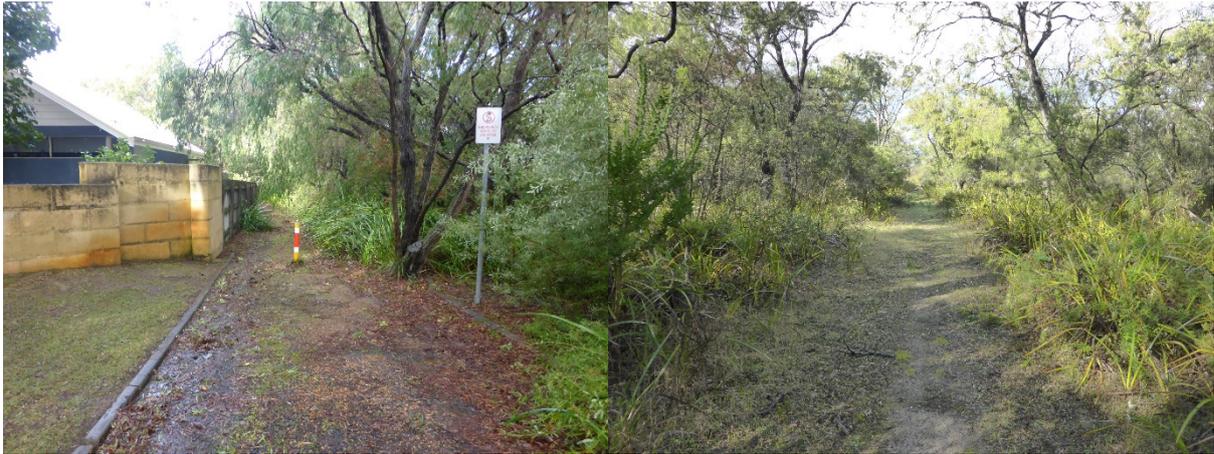
Figure 3-4 Emergency access off Lagoona Place that could be improved with new hot mix.

Figure 3-5 Firebreak from the Boat Club overflow carpark to Champion Way that could be formalised with compacted limestone.

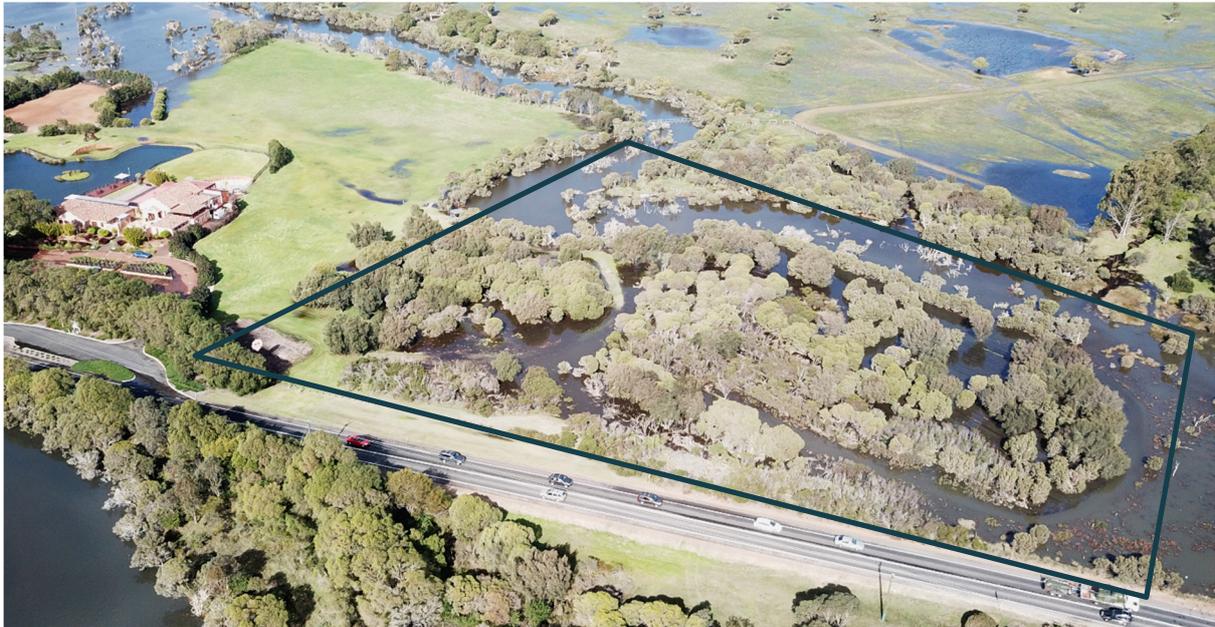
Figure 3-6 Caves Road, Palmers Estate to the left and the section of Toby Inlet outlined within the study area in the mid ground. Note although flooded in this picture there are extensive mowed grassy walkways that could be formalised with crushed limestone.

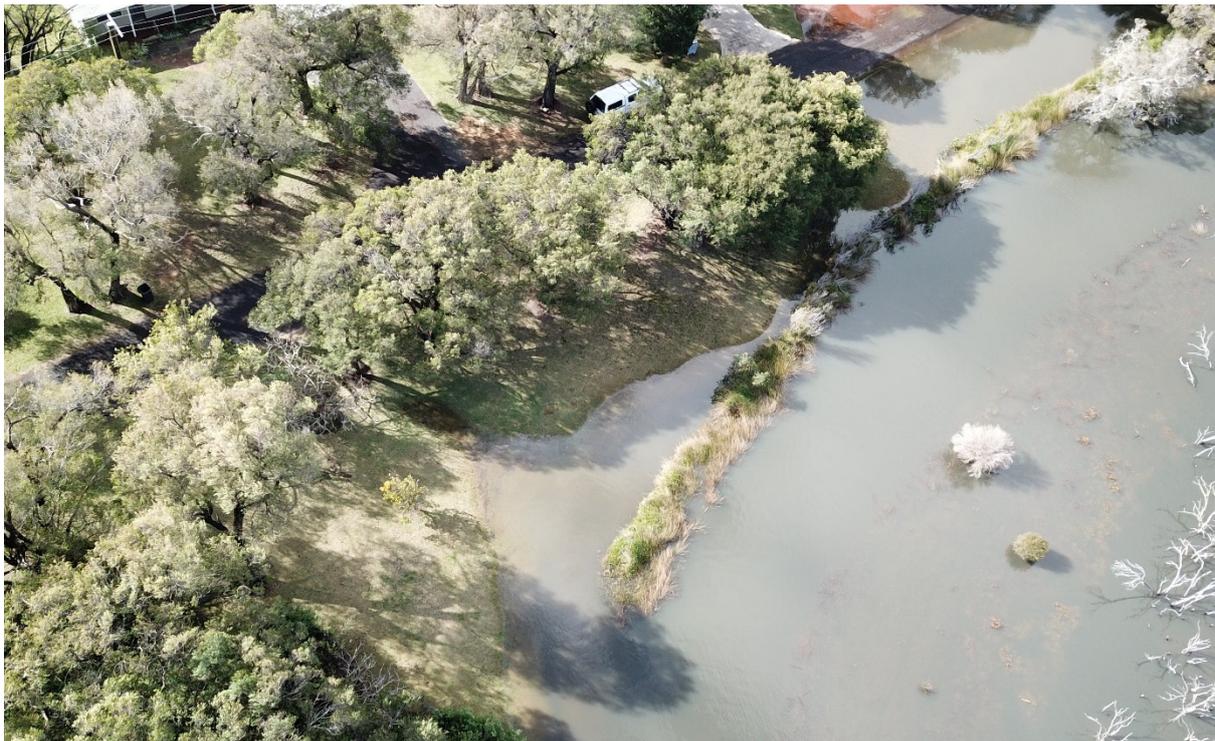
Figure 3-7 Maintained parkland at Wilson Avenue where a defined pathway would define the reserve boundary and protect fringing vegetation.

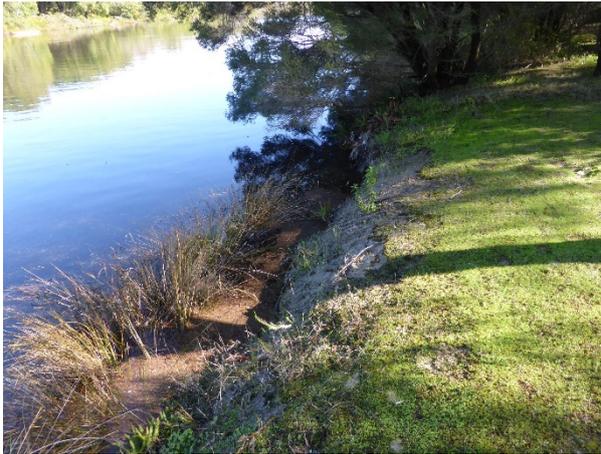
Figure 3-8 Example of erosion at Mc Quade Park (Campion Way) due to loss of stabilising foreshore vegetation.

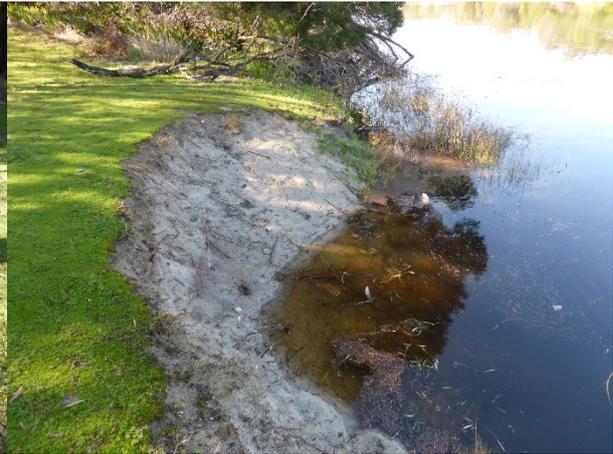
Figure 3-9 Example of erosion at Mc Quade Park (Campion Way) due to loss of stabilising foreshore vegetation.

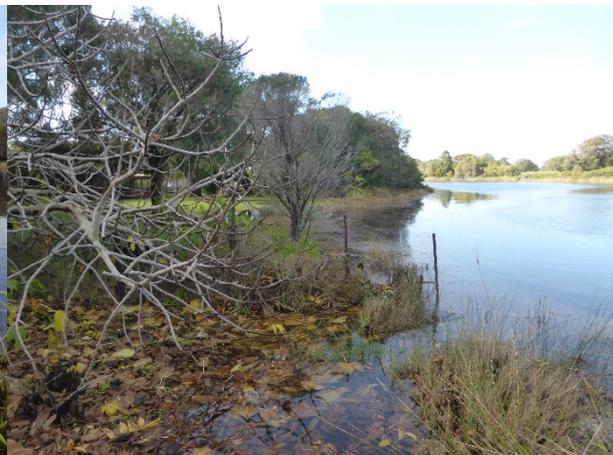
Figure 3-11 Cleared area off Bloor Street showing clearing from adjacent landowner and fencing to the water edge.

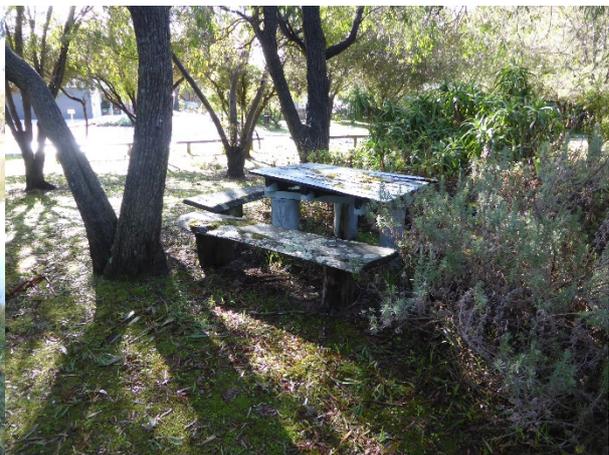
Figure 3-18 Derelict table (WP 8)

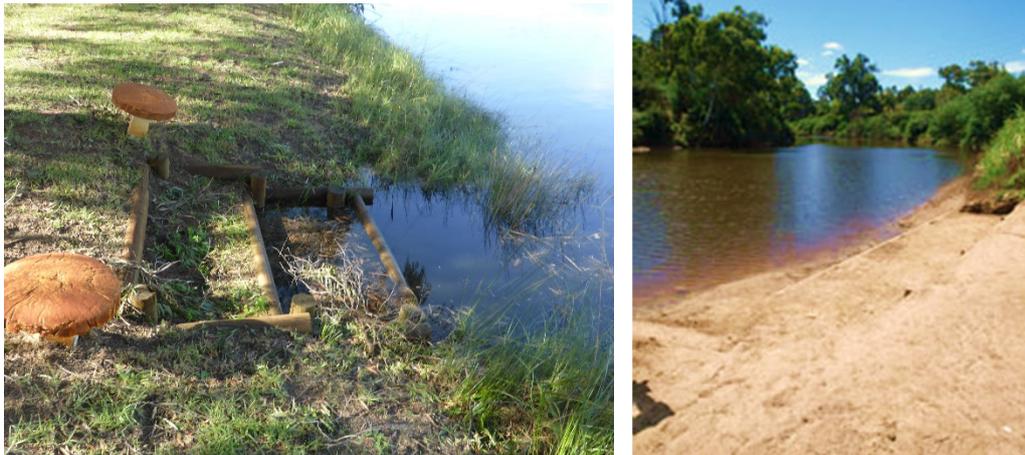
Figure 3-19 Examples of stepped retaining walls that could be enlarged for canoe access, or as a fishing platforms in degraded areas.

- Close access to parking,
- Located downstream enough so that water levels are adequate for most of the year,
- Ensure the natural bank is stabilised,
- Ensure construction materials will withstand periodic inundation,
- Include appropriate signage,
- Alternative use as a fishing platform.

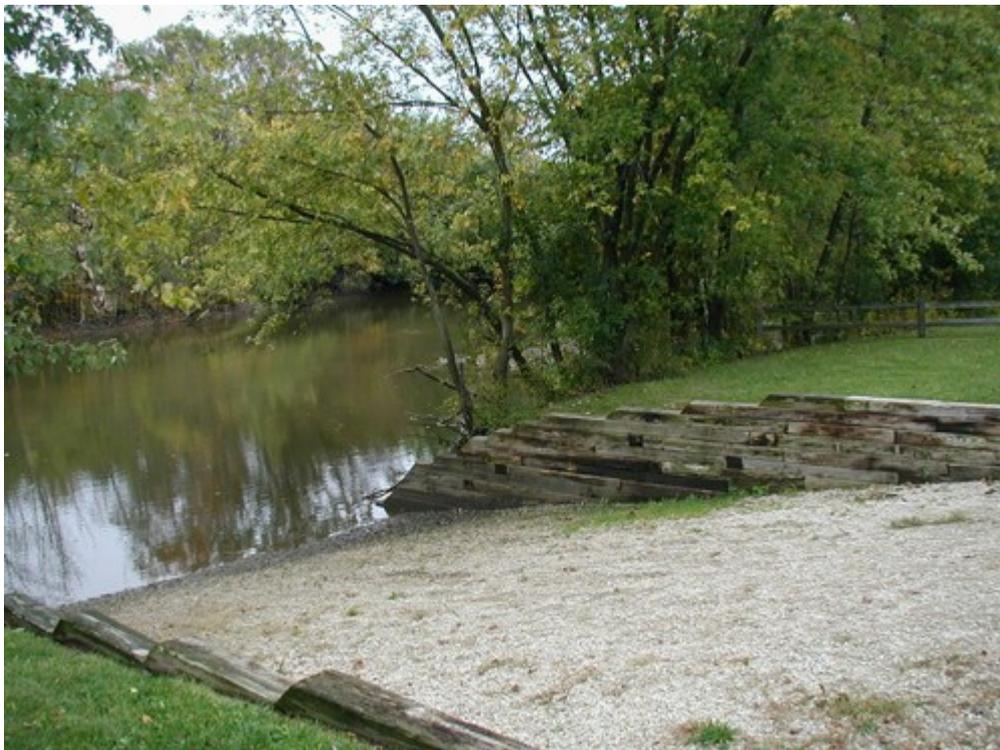
Figure 3-20 Example of graded access to the water mark. Note that retaining walls would still be required at the bank cutting. Source: <https://www.lcfd.org/launches/>

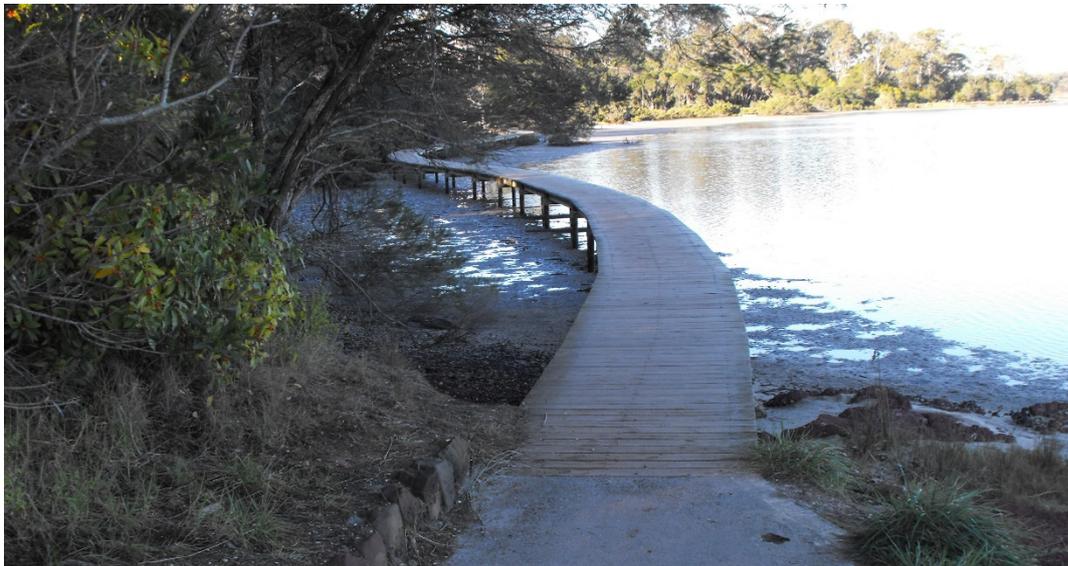
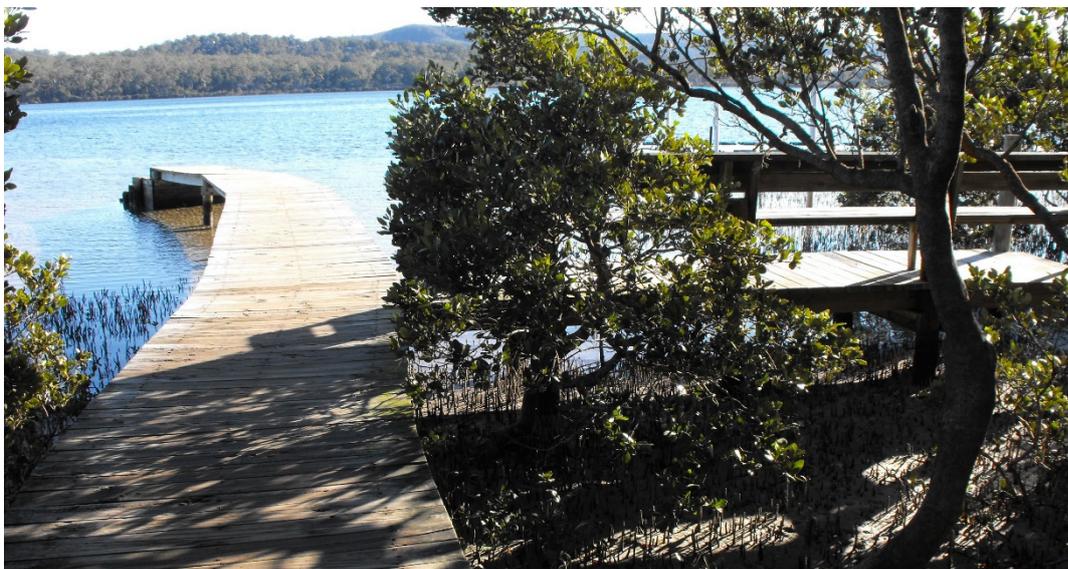
Figure 3-21 Boardwalk examples around Bottom Lake, Merimbula

These are low key features, relatively cheap to build, with low construction impacts if constructed during summer low water level months (with little or no clearing required). They have been adopted with high success by other local governments in high value sensitive coastal lake locations such as Bottom Lake, Merimbula (Bega Valley Shire Council) (see Figure 3-21) and Narooma Foreshore (Eurobodalla Shire Council). A starting point for the installation of a boardwalk might be the 100m and 70m private property sections between Stone Street and Lagoon Place, which would then enable a continuous pathway of about two kilometres long.

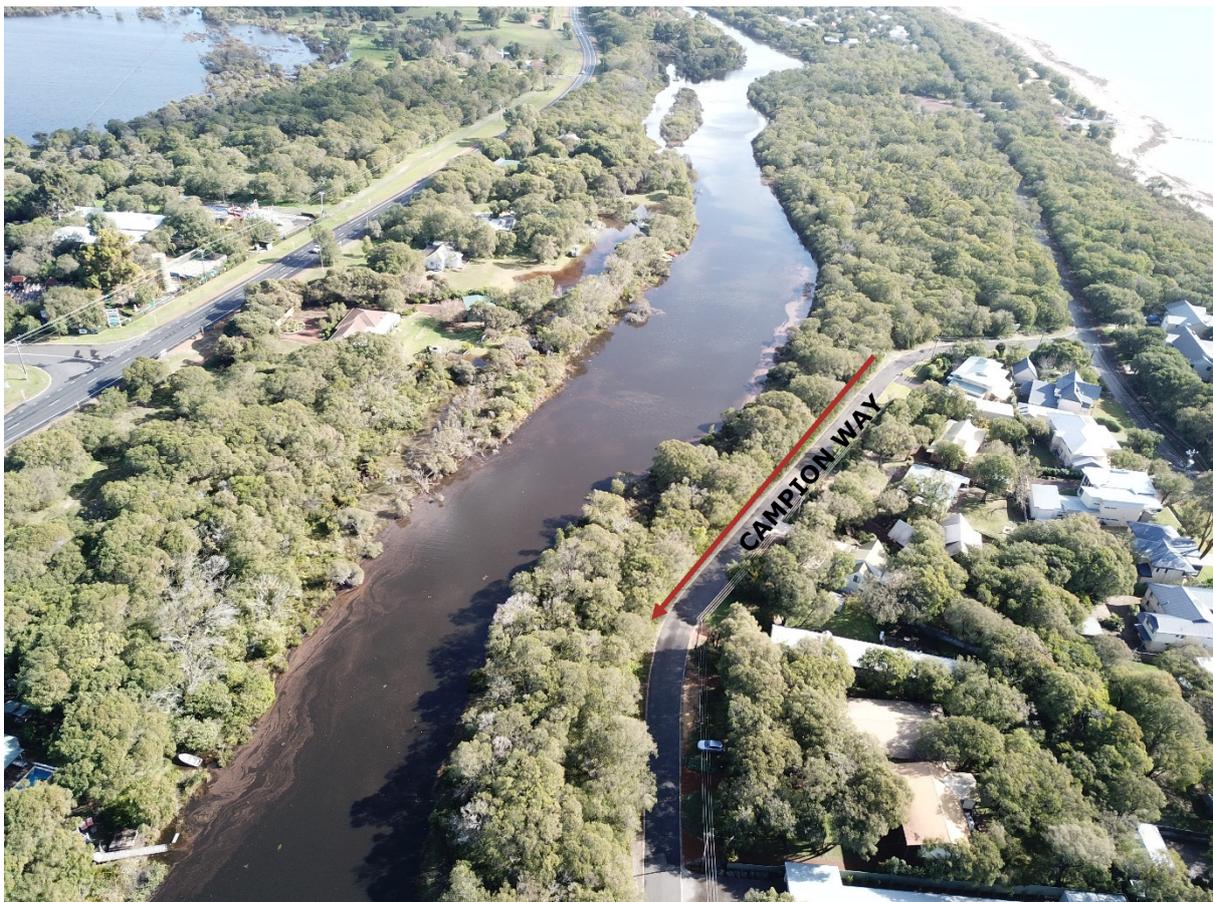
Figure 3-22 Clearing required for a pathway along the southern Campion Way roadside (see red line).

An example would be the construction of a pathway along Campion Way road reserve linking Mc Quade Park to the east to the existing pathway off Campion Way to the Boat Ramp parking lot. Low impact clearing of sword sedge would be required.
