**CITY OF BUSSELTON
COASTAL MANAGEMENT PROGRAM
10 YEAR PLAN (2020 – 2030)**

for City of Busselton.

October 2020

SCR1707

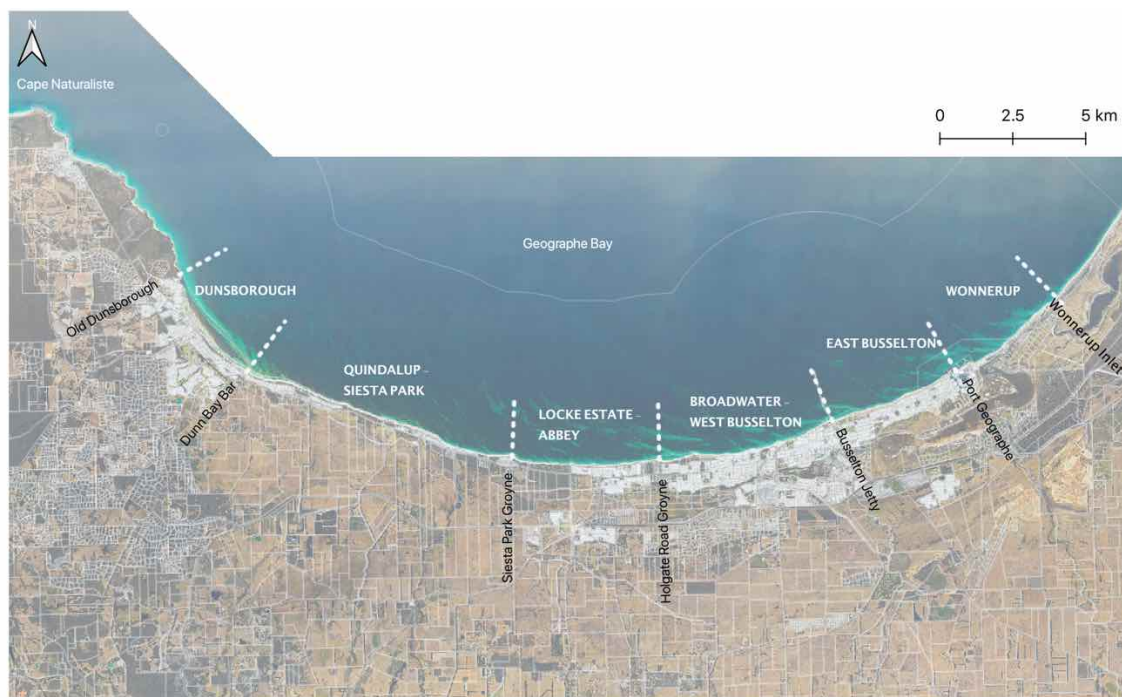
Figure 1.1 City of Busselton – Geographe Bay Coastal Management Areas

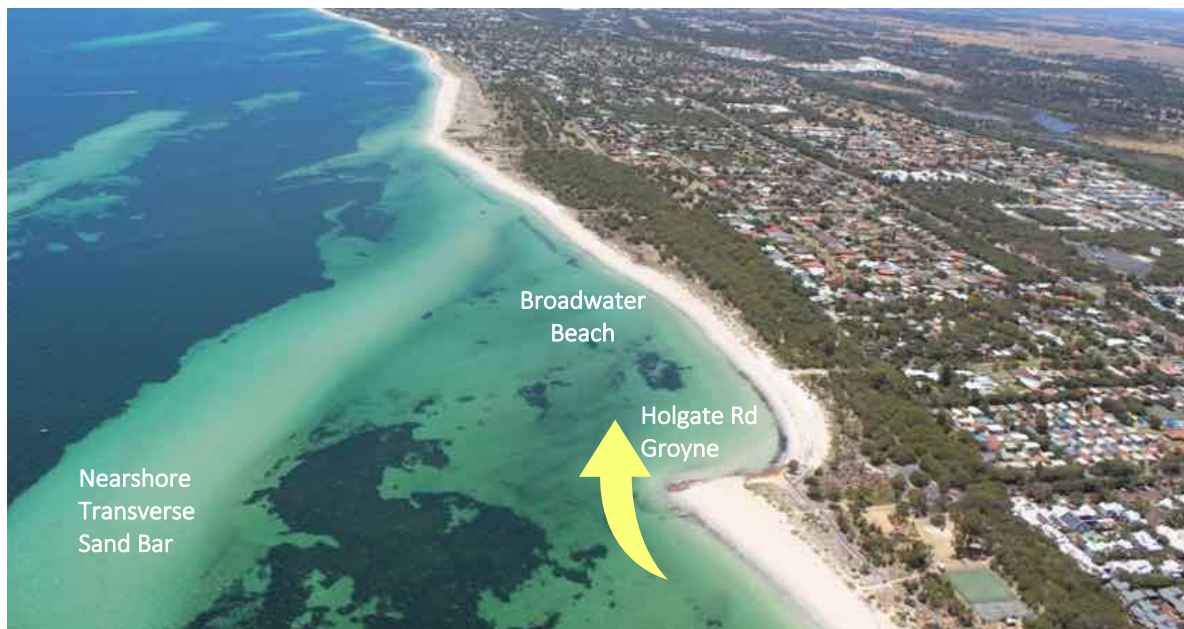
Figure 1.3 Broadwater Beach - Holgate Road Groyne. In 2020 this structure was refurbished and shortened by 20m to improve supply of sand to Broadwater Beach

The shortening of groynes at Siesta Parka, Holgate Road and Wonnerup periodically arises in community consultation as a potential solution to mitigate downdrift erosion. The Holgate Rd groyne was refurbished in 2020 and was reduced in length by 20m (Figure 6.5).

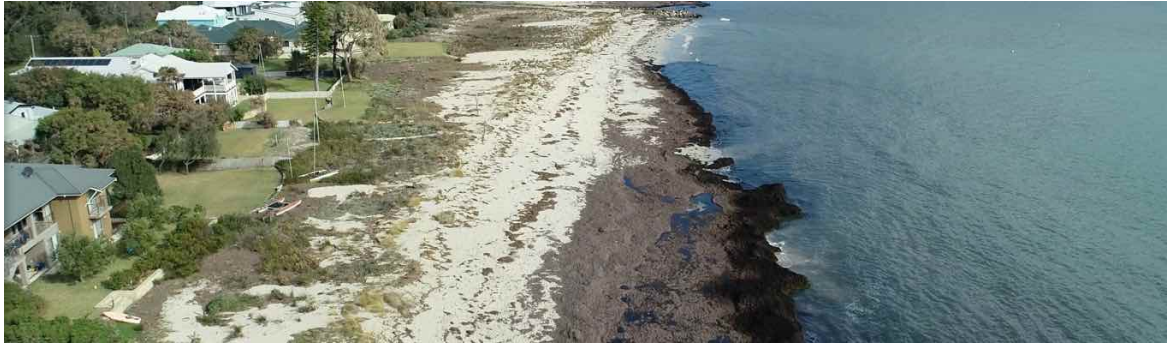
Figure 3.2 Post Storm UAV Imagery (2018)

In June 2018, high resolution videos of the Geographe Bay shoreline following a severe storm were taken using a UAV video. This has been integrated with coastal engineering interviews and storm footage into a short video that will be made publicly available. This is part of the City's commitment to ongoing consultation with regard to their Coastal Management Program.

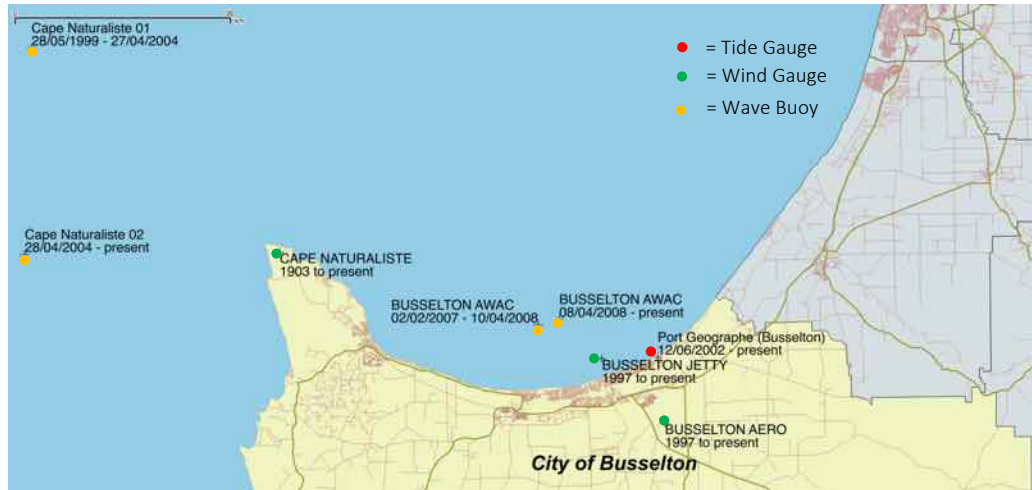
Figure 4.1 Historic and Ongoing Metocean Monitoring Locations

The Busselton AWAC (7km NW of Busselton Jetty) has been in-place for more than 20 years but will be removed in October 2020, with a new instrument deployed near Port Geographe (D Hanson, DoT, pers comm). Whilst the CMP includes the installation of a wave recorder on the Busselton Jetty, there will be no strategic monitoring of nearshore waves in Geographe Bay in the interim.

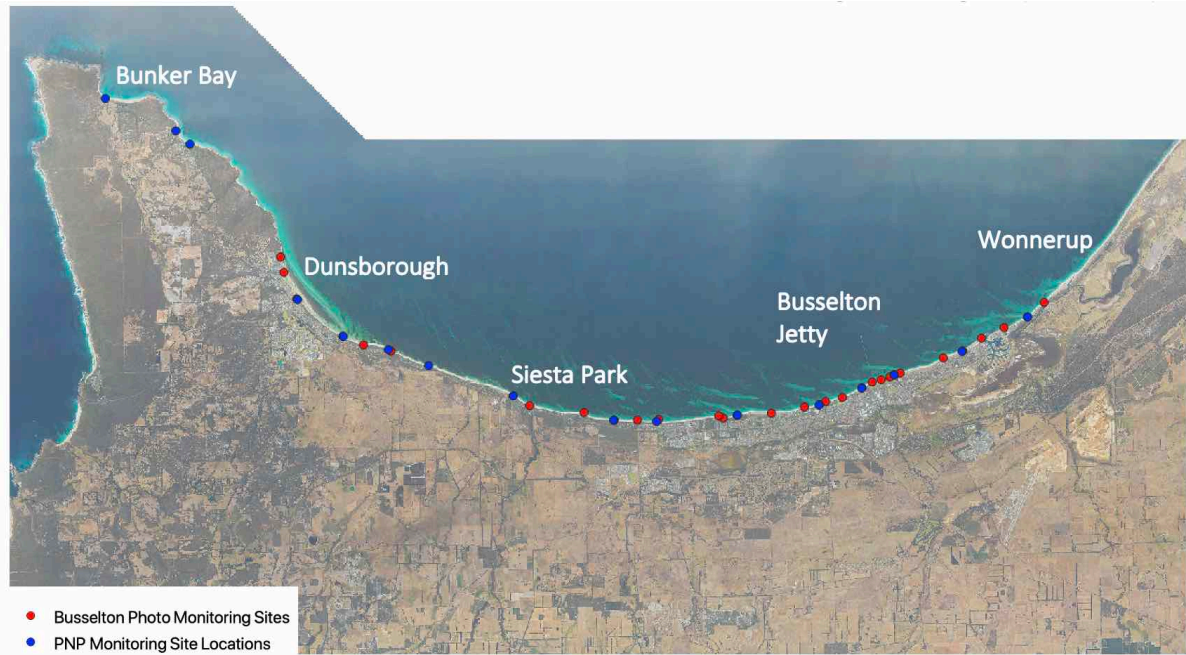
Figure 4.5 Location of the 32 City of Busselton monitoring sites, and 16 PNP monitoring sites.

In addition to the annual beach monitoring, photo monitoring has also been undertaken as part of the PNP monitoring at 16 sites on a monthly basis (Figure 4.5, Attachment 1). This PNP monitoring includes beach width measurements.

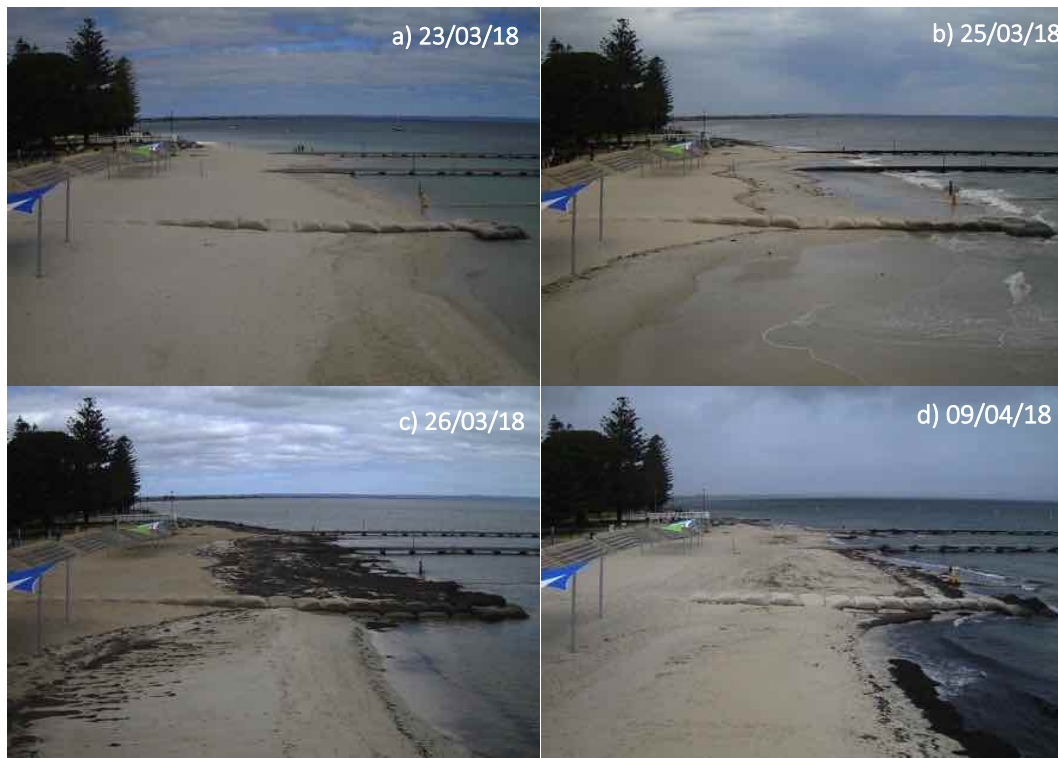
Figure 4.6 Busselton Jetty Fixed Camera Monitoring showing wave runup (b) and wrack deposition associated with TC Marcos (c) and localised scour downdrift of groyne (d)

A fixed camera was installed at the Busselton Jetty in November 2018 for a trial 12-month period. The camera takes a daily photo of the beach to the west of the Jetty (14). Fixed camera monitoring is also undertaken by DoT to monitor seagrass wrack accumulation on the Western Beach and Port Geographe, and beach behaviour at Wonnerup.

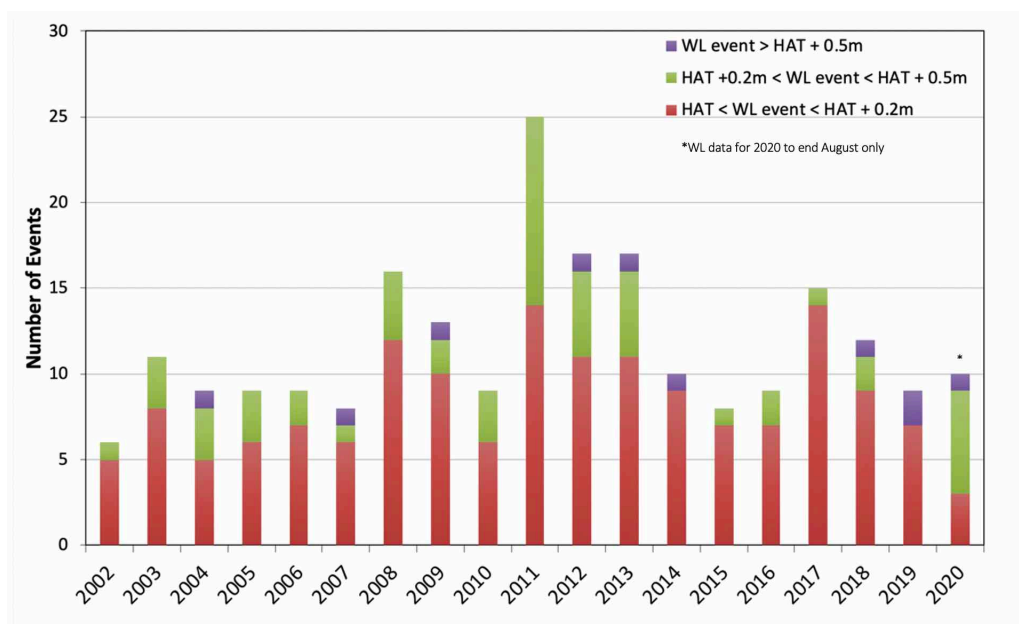
Figure 5.1 Relative Storminess in Geographe Bay based on Number of High Water Level Events Recorded at the Port Geographe Tide Gauge Each Year.

Coastal monitoring data allows the relative storminess to be compared between years. It is noted that the years preceding the 2014 -2018 program were relatively stormy, whilst conditions during the program have been relatively calm (Figure 5.1.).

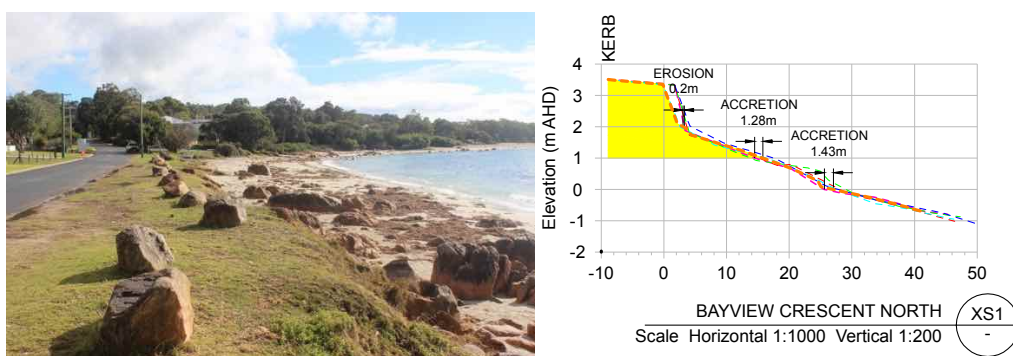
Figure 5.2 Bayview Crescent North Annual Monitoring Beach Profile Survey December 2017. Note Minimum Buffer to Assets Shaded in Yellow

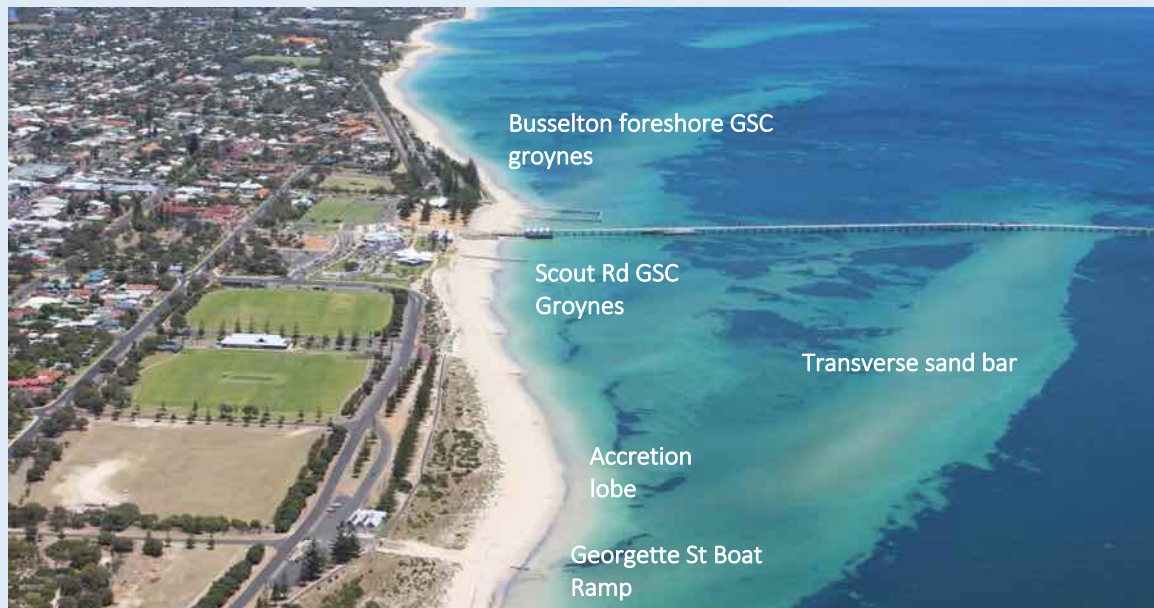
The Busselton Foreshore is a very popular community area for both locals and visitors to Busselton. This precinct has undergone significant upgrades over the last decade, with coastal protection measures allowing the development of valuable community space. In 2008 a GSC groyne field was constructed to replace timber groynes. These timber groynes were not maintained and had deteriorated, resulting in beach erosion and collapse of a concrete promenade in July 2007 winter storms. While these 35-45m long groynes increased the width of the swimming beach west of the jetty, they also reduced sand supply to the beaches to the east. By the time the CMP (2014-18) was prepared, it was evident adaptation and protection measures would be required at Scout Rd and to the east.

The strategic approach of the CMP (2014-18) encouraged the use of a refined groyne design and consideration of transverse sand bars and onshore sand feeds. This reduced the cost of protection and reduced the potential for impact further downdrift. Coastal monitoring was continued to measure success. The Scout Road GSC groyne extended eastward to an accretion lobe at Georgette St and a transverse sand bar which was identified in an earlier sediment budget study as an onshore sand feed. Further strategic investigations of these transverse sand bars along Geographe Bay is proposed in the current CMP.

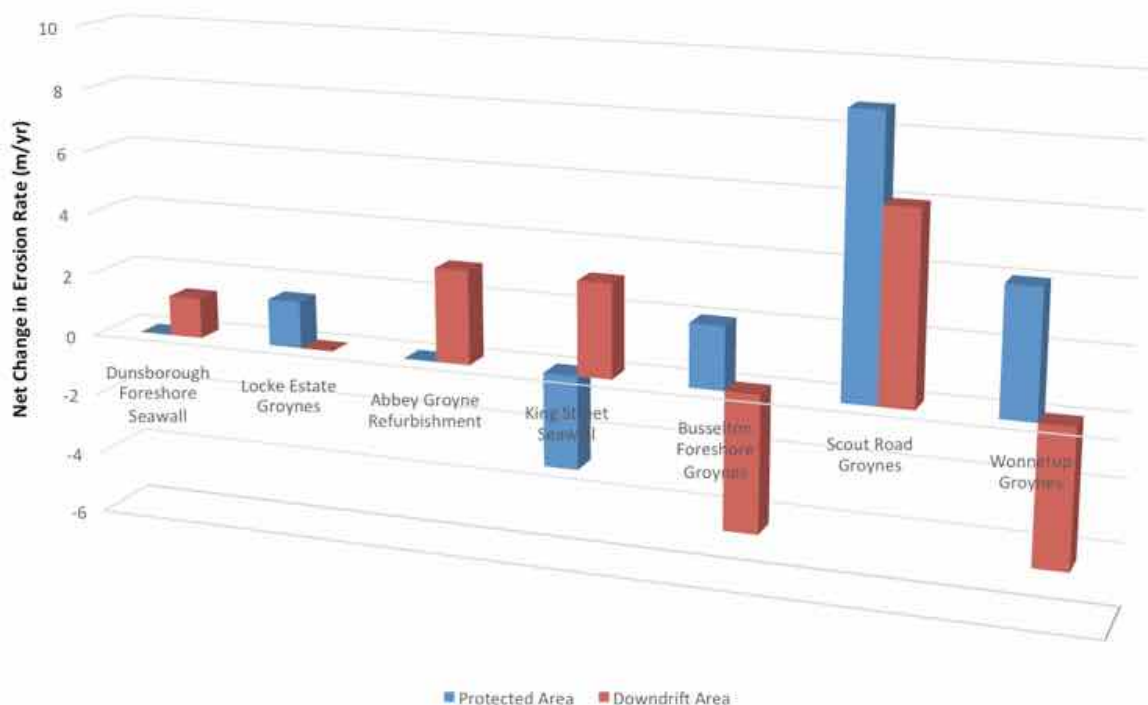
Figure 5.4 Net Change to Erosion Rate for Protected Area and Downdrift Areas Associated with Coastal Protection.

- Managed retreat projects (Dunsborough/King St) have resulted in net erosion in the protected area (as a structure is removed and a beach is allowed to realign), but net accretion in downdrift areas, as the cause of localised erosion (the structure) is removed or re-located landwards.

- The groynes at Wonnerup (Baudin Reserve) have shifted the erosion away from the area with higher value assets to the foreshore reserve to the east. This requires ongoing monitoring.

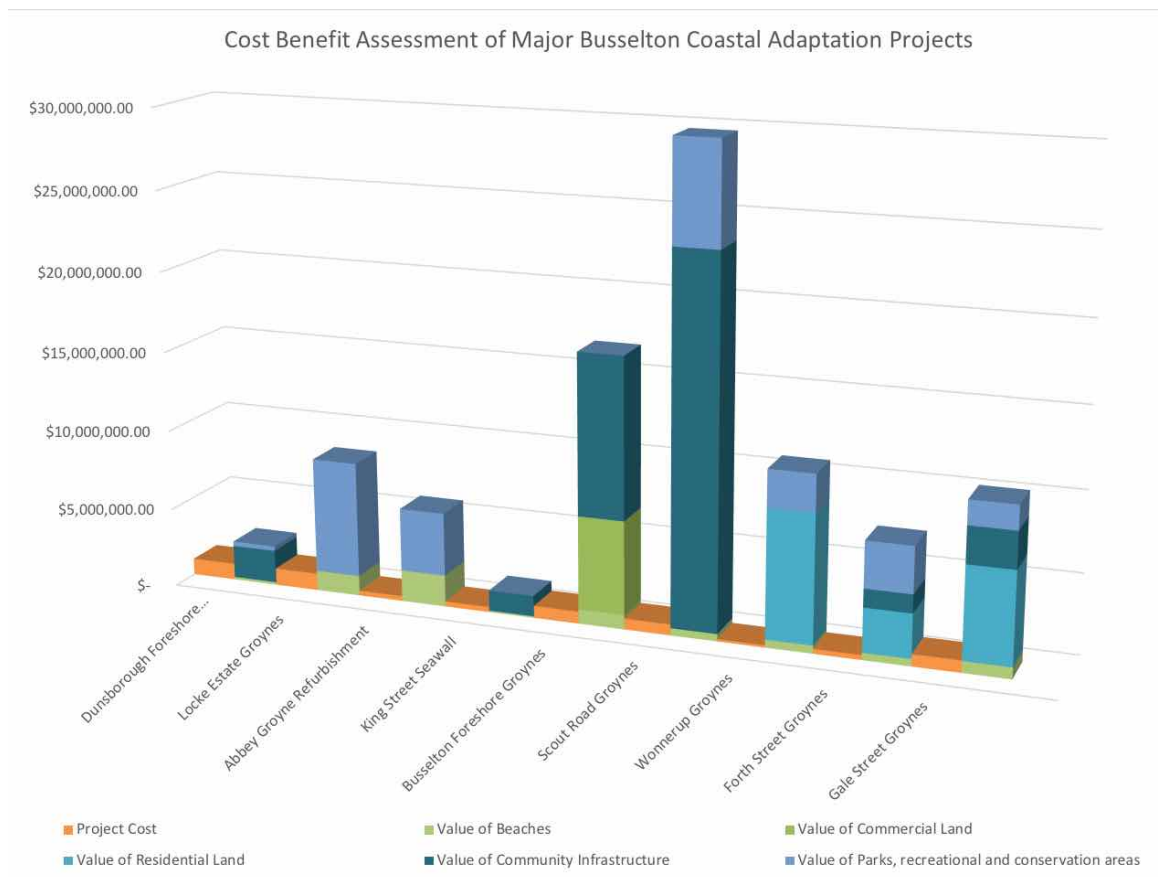
Figure 5.5 Coastal Adaptation – First Pass Cost Benefit Assessment

- Coastal stabilisation projects at Locke Estate, Busselton Foreshore and Scout Road have a favourable Cost-Benefit ratio due to the value of community infrastructure and the adjacent beach.
- Maintenance of the Abbey groynes field has a relatively high cost benefit ratio due to the low cost of maintaining coastal structure relative to the economic value of protected recreational areas and the beach.
- Managed retreat projects at Dunsborough and King St have a lower cost benefit ratios they have been generally more focussed projects in areas of localised erosion.

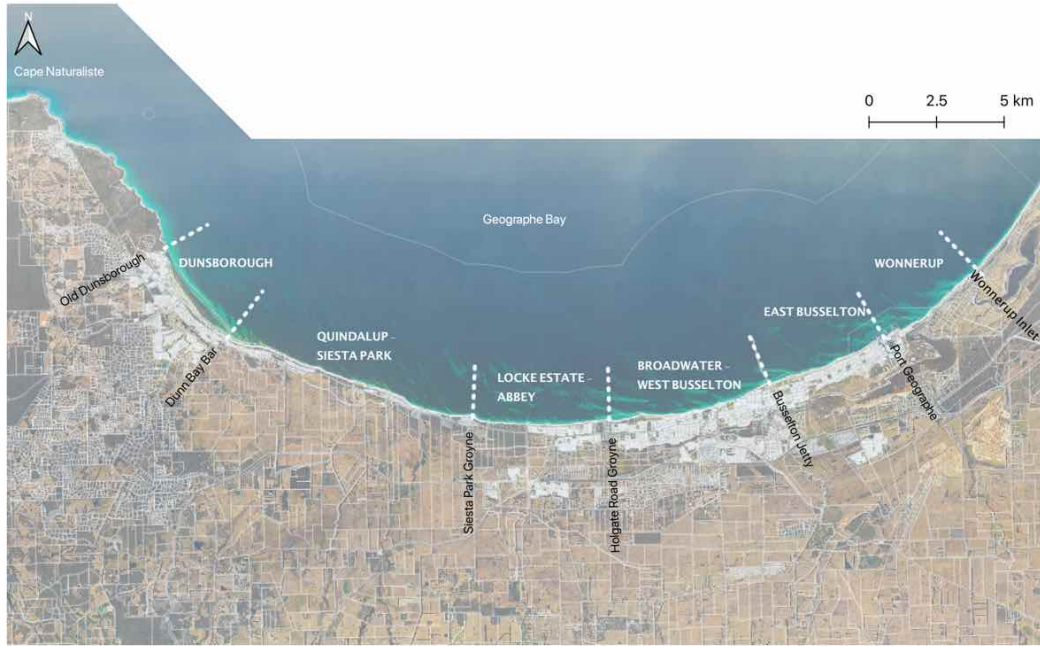
Figure 6.3 Geographe Bay Coastal Management Areas

5. East Busselton	Busselton Jetty	4.3	NNW	Sandy coastline including foreshore east of Busselton Jetty, Scout Rd, Georgette St boat ramp, East Busselton foreshore and wrack accumulations on western beach of Port Geographe.

6. Wonnerup	Port Geographe (to Wonnerup Inlet)	4.4	NW	Sandy coastline including Wonnerup Beach, East Wonnerup (Baudin Reserve) and Wonnerup Inlet.

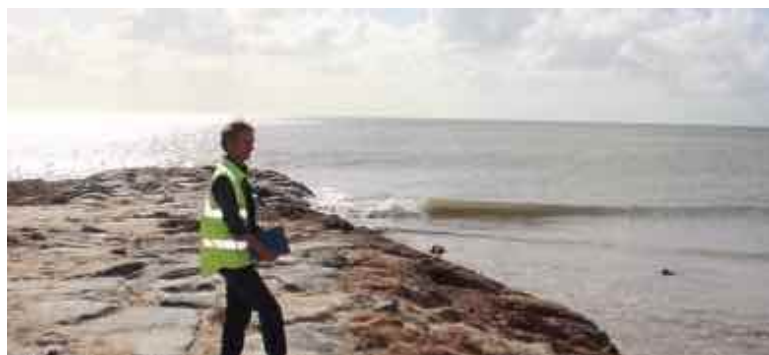
Figure 6.5 Holgate Rd Groyne Refurbishment 2020

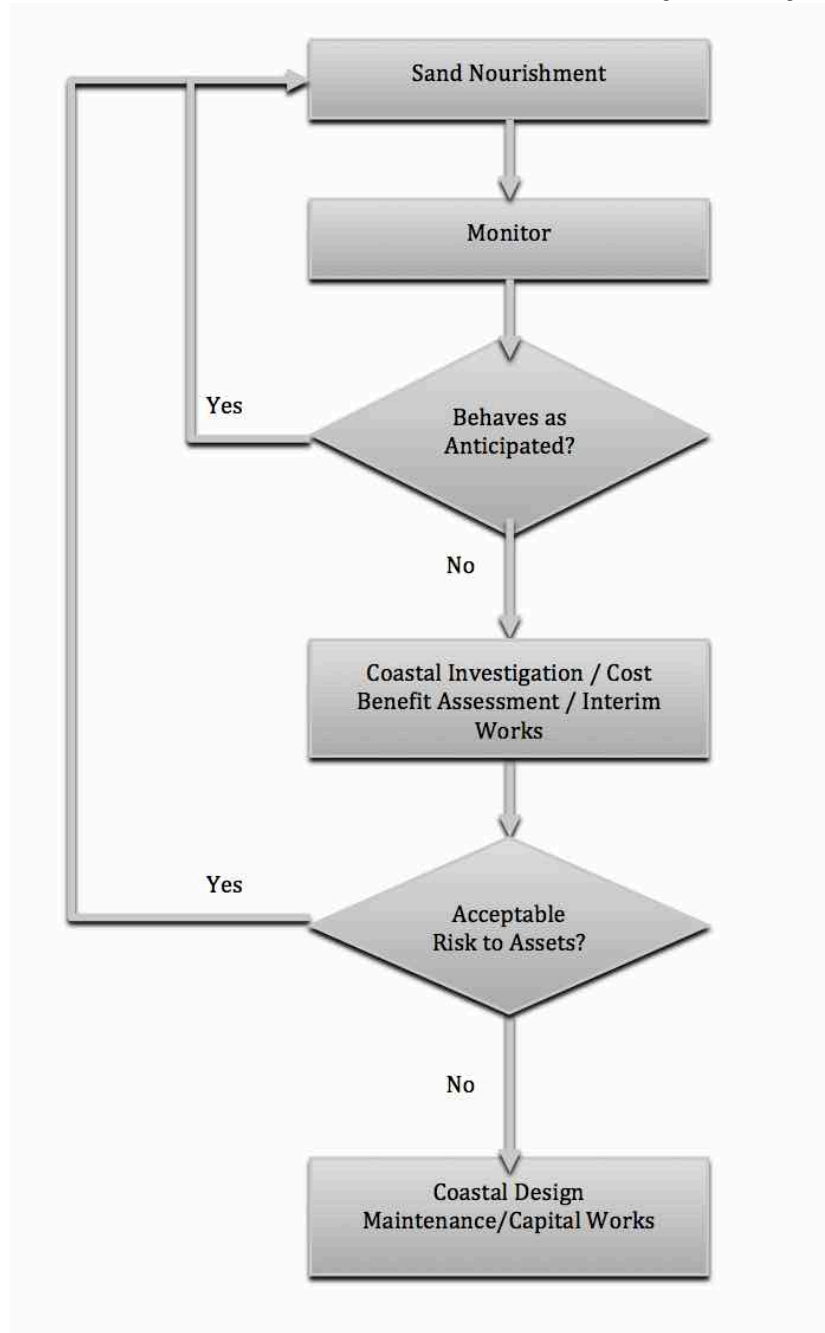
Figure 6.7 Flow Chart for Transitioning from Sand Nourishment to Coastal Stabilisation

The flow chart below illustrated a decision-making framework for transitioning from sand nourishment to Maintenance or Capital Works (Figure 6.7). For example, Broadwater Beach continues to be nourished with sand, however concepts have been developed for asset relocation and coastal stabilisation following a coastal adaptation review and multi-criteria analysis.

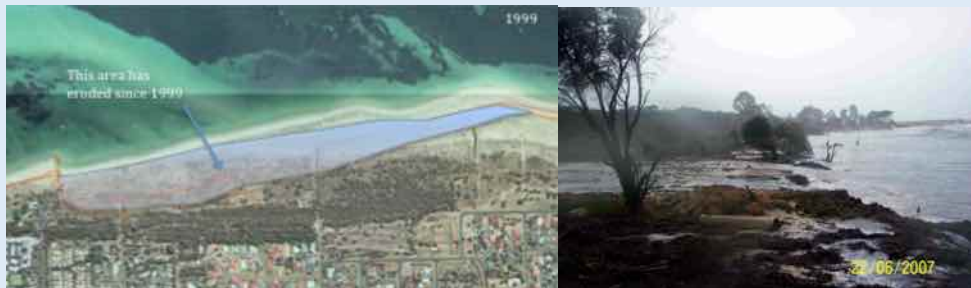
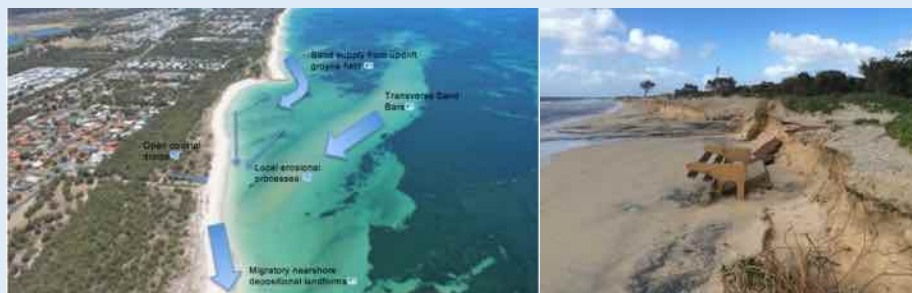
In 2018, at the observed rates of erosion (5m/yr) the consequences of ongoing erosion were potentially loss of DUP within 1 year, erosion of private property within 2 years, erosion of peppermint woodland (habitat for the threatened western ringtail possum) within 3 years and complete erosion of the foreshore reserve and associated habitat within 15 years.

In recent years the coastal path at Allen St that was subject to ongoing erosion has been realigned away from the coast. The refurbishment of the Holgate Road groyne was completed in 2020 with a 20m reduction in the length of the groyne intended to increase the supply of sand to Broadwater Beach. This was Stage 1 of planned coastal adaptation works. This also required construction of a GSC groyne to the west to ensure the coastal path in that area remained protected. Sand nourishment occurred in Stage 1 in 2020 to provide a supply of sand to the beaches to the east, and maintenance sand nourishment will continue in the future.

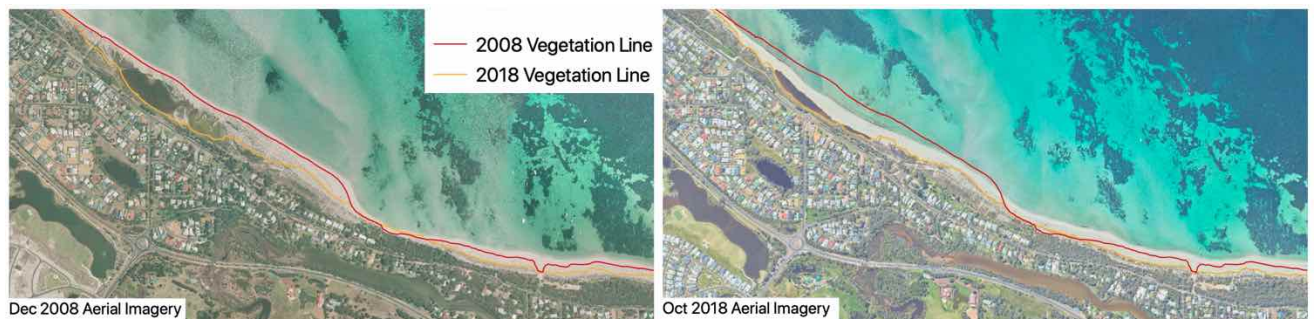
Figure 7.1 Dunn Bay Bar in 2008 (left) and 2018 (right) showing variability of sediment supply

Ongoing monitoring is required to track the behaviour of the Dunn Bay bar, which is a major sediment supply pathway for Geographe Bay (Figure 7.1). The rate of supply of sand will not always balance the rate of migration of sand away to the east due to variability of natural processes.

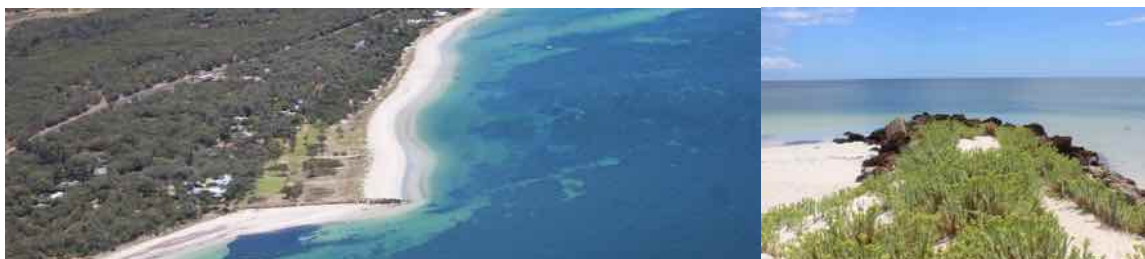
Figure 7.3 Siesta Park Groyne (Dec 2017)

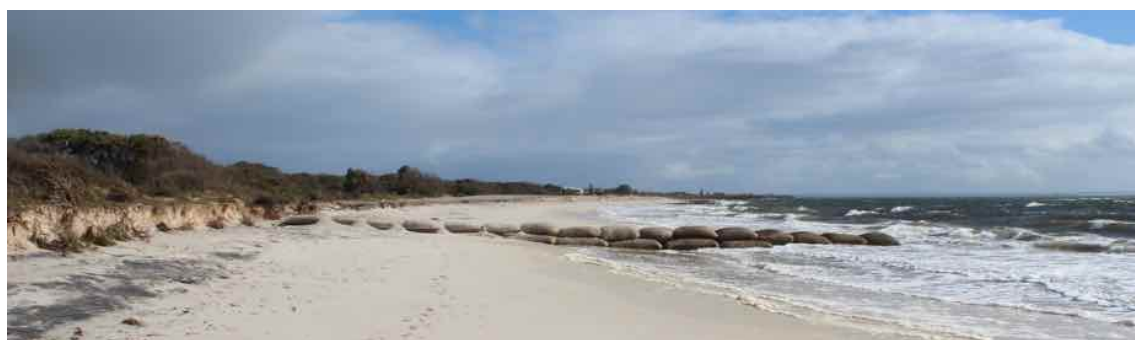
Figure 7.9 Trial Groyne at East Wonnerup (Aug 2017)
