A MANAGEMENT PLAN FOR DUGALUP BROOK
CROWN RESERVE 42673, BETWEEN CAPE
NATURALISTE ROAD AND NATURALISTE TERRACE,
DUNSBOROUGH

Adopted August 2008

Sue Elscot & Floyd Irvine
Green Iguana

For the Shire of Busselton

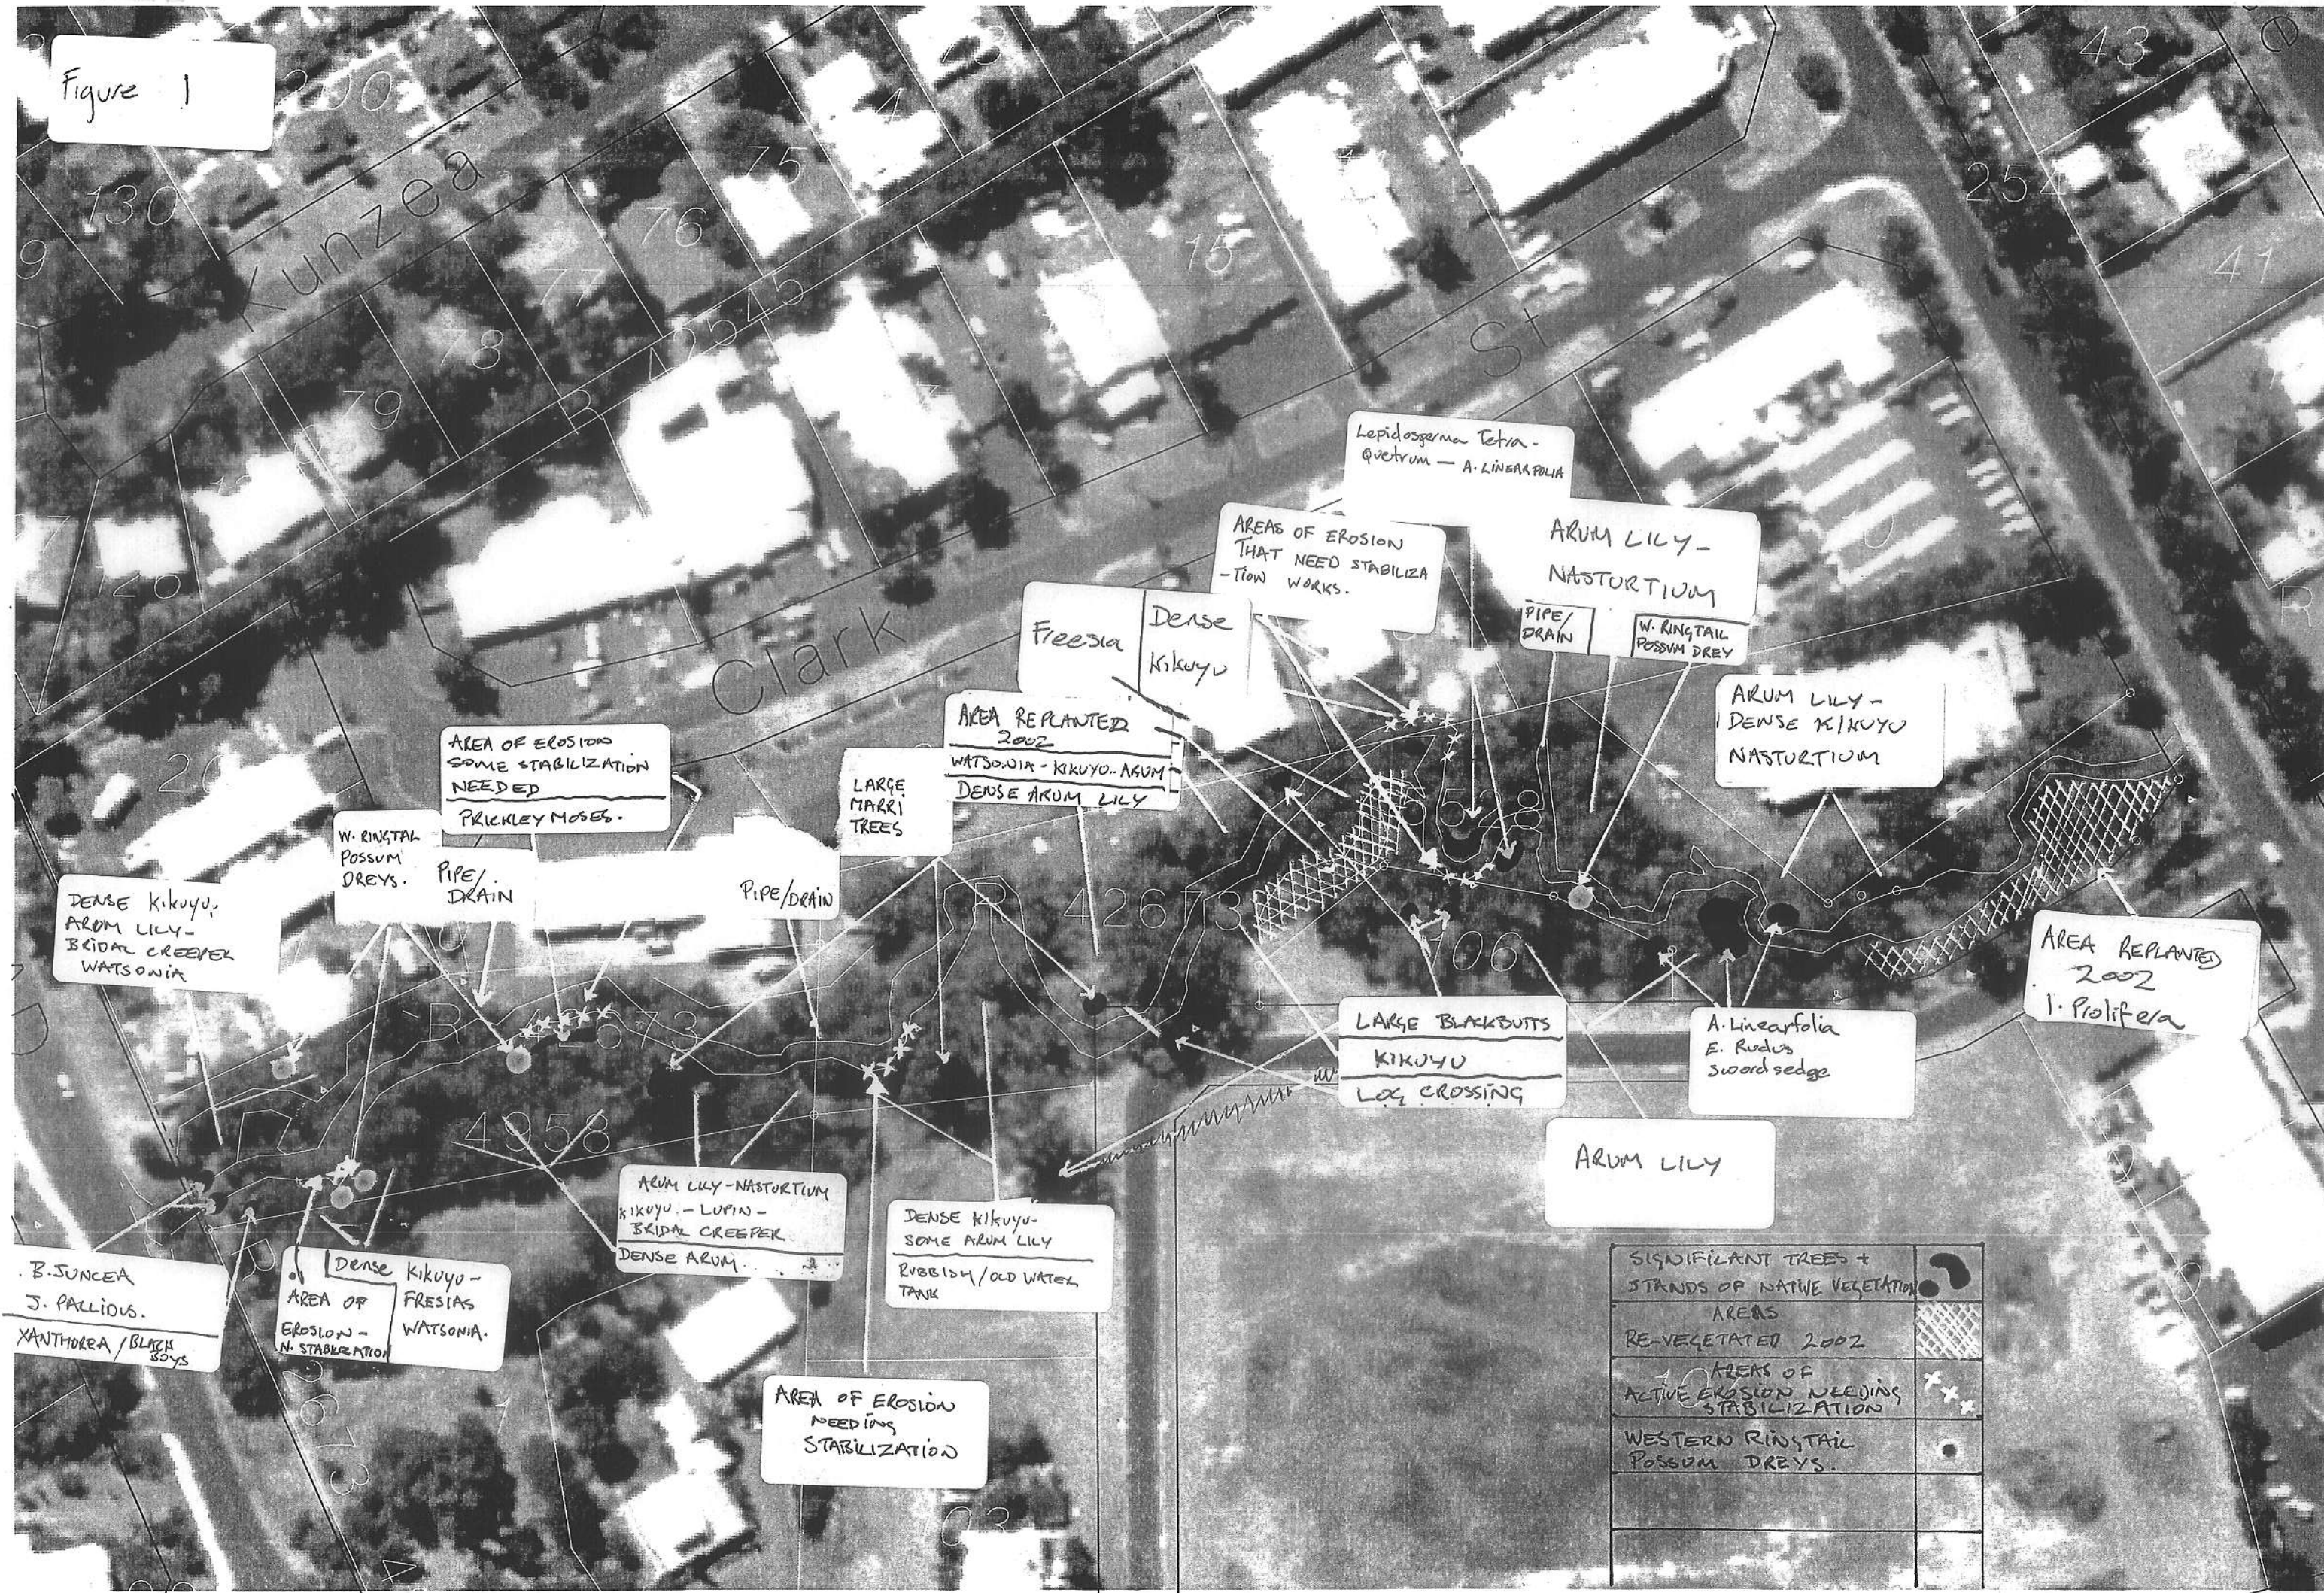
Figure 1

At the commencement of the project (September 2005), the current condition of the study area was investigated and mapped. Figure one shows: the condition and extent of native vegetation remaining within the reserve including landmark trees; presence and extent of exotic vegetation (weeds present during spring); areas of erosion requiring stabilisation; foreshore disturbances including pedestrian crossings and informal paths; and stormwater outlets and detention basins. The following sections of the plan

SIGNIFICANT TREES + STANDS OF NATIVE VEGETATION	
AREAS RE-VEGETATED 2002	
AREAS OF ACTIVE EROSION NEEDING STABILIZATION	
WESTERN RINGTAIL POSSUM DREYS.

Although the reserve retains continuous canopy cover for most of its area, there are only nine small areas which retain good condition native understorey (figure 1). Near Cape Naturaliste Road, there are stands of the native sedges pale rush (*Juncus pallidus*) and blue twig-rush (*Baumea juncea*) lining the stream, and patches of blackboys (*Xanthorrhoea preissii*) and prickly Moses (*Acacia pulchella*) are present under peppermint trees (figure 1). Within the area of flooded gums (adjacent to and downstream of Lot 106) there are five small areas where the understorey is dominated by the shrub swamp peppermint (*Taxandria linearifolia*) over four-sided sword sedge (*Lepidosperma tetraquetrum*) or spreading sword sedge (*Lepidosperma effusum*) and river twig-rush (*Baumea rubiginosa*) (figure 1). Other native understorey plants present within the reserve include soap bush (*Trymalium floribundum*), swishbush (*Viminaria juncea*) and native wisteria (*Hardenbergia comptoniana*).

and erosion of the toe of the bank resulting in undercutting and bank slumping. Several mature peppermint trees have been undermined and have either fallen into the brook or are adding weight to the shoulder of the bank and increasing the likelihood of further bank collapse. The outside bend of the brook near the area proposed for a playground is also incising and undercutting, however this erosion is not as severe as that which is occurring near Lot 106 (figure 1). Another section of the brook near Lot 22 Clarke St is also actively eroding, primarily due to the lack of fringing vegetation on the bank, and this area is less severe than the two downstream areas of erosion (figure 1). There is also a minor area of erosion on the outside of a bend near Cape Naturaliste Road, also due to lack of fringing vegetation (figure 1).

There are currently two stormwater detention basins and one 'bubble-up' located within the reserve to treat run off from Cyrillean Way (figure 1). These detention basins were installed and planted with locally occurring native riparian species in 2002. The detention basins appear to be functioning within their capacity as the upstream basin rarely overflows and, at most times, stormwater appears to percolate through the soil instead (Chris Hoskins, DCALC, pers. comm.). The downstream basin overflows regularly, however it appears to detain a significant amount of stormwater before overflowing and the sedges within the basin are thriving.

Currently there are numerous informal paths within the reserve, providing access to town from businesses in Clarke Street, and linking Cape Naturaliste Road to Cyrillean Way and Clarke Street. The path between Clarke Street and Cape Naturaliste Road is well worn indicating that it carries a substantial amount of pedestrian and possibly cycle traffic. There are also numerous informal creek crossings, most of which are makeshift constructions of wood and packing crates. Near the corner of Cyrillean way there is a fallen log that provides an all-weather crossing of the brook and the path that leads to this crossing also shows a regular usage (figure 1).

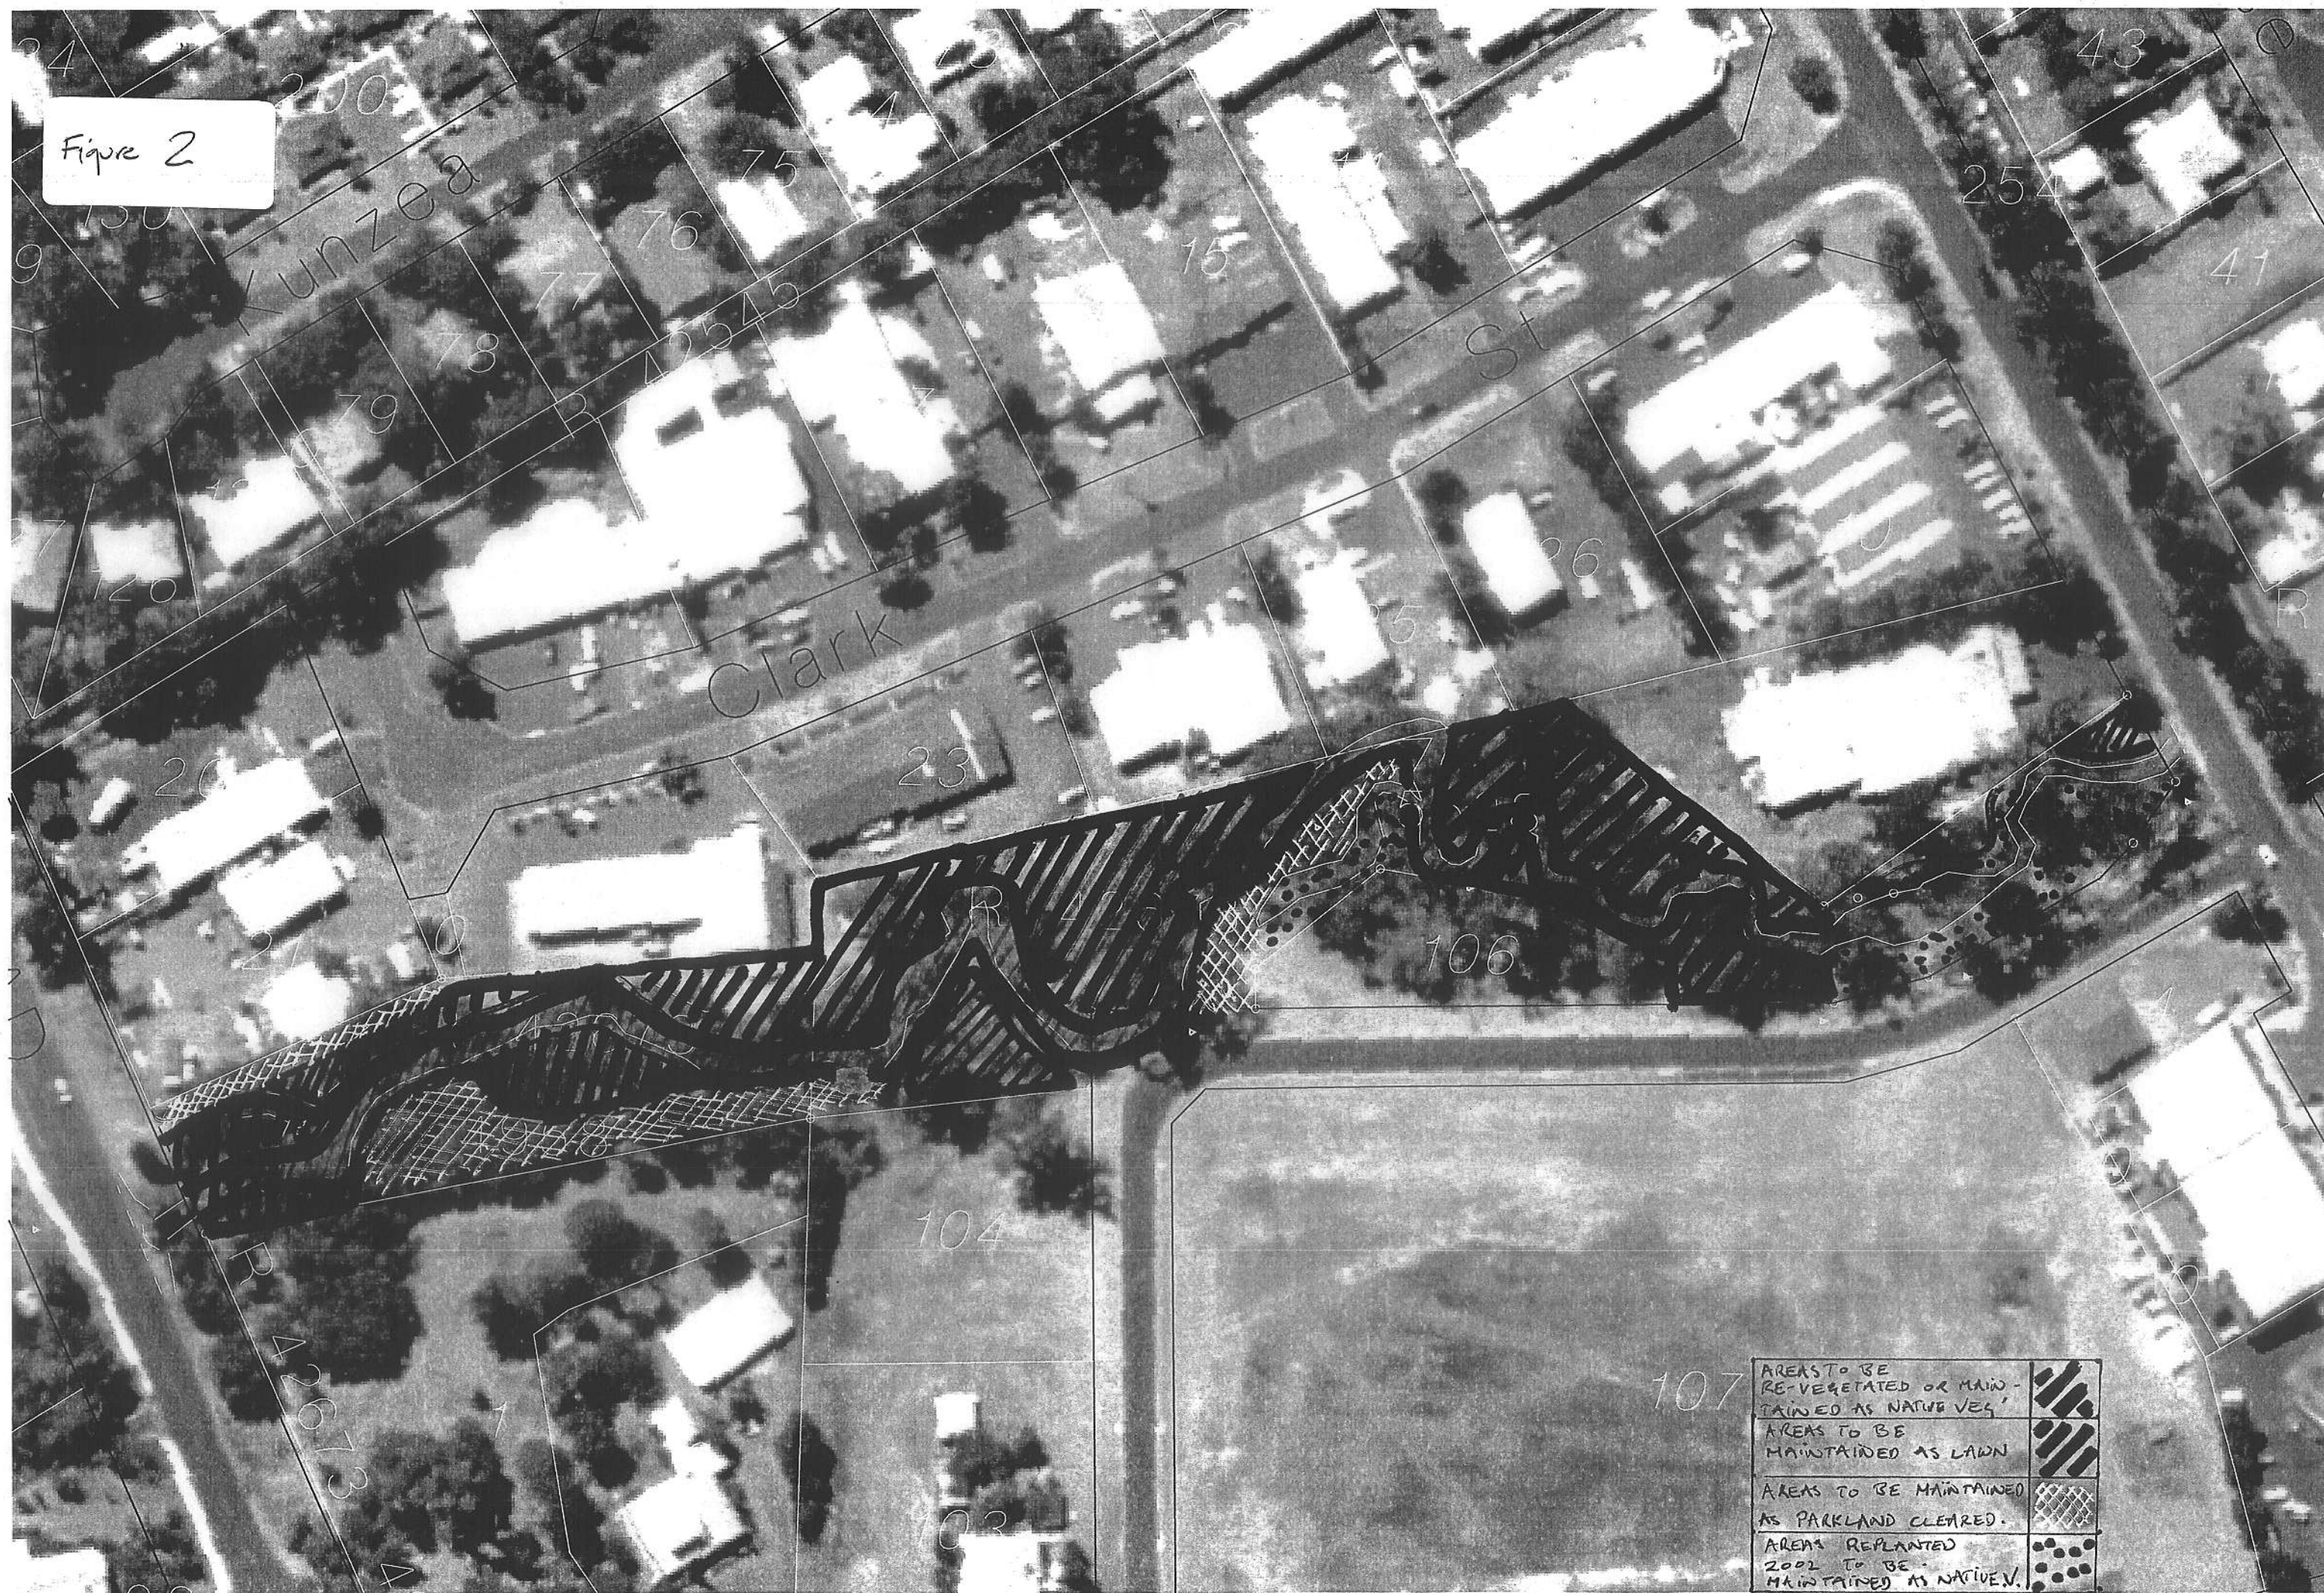
A key objective of this concept plan is to restore the ecological values (e.g. fringing vegetation, native fauna) and functions (e.g. water flow, nutrient stripping, flood control) of Dugalup Brook. To achieve this objective, all areas of the reserve which are not required for social function purposes will be replanted with appropriate, locally occurring native plant species. Figure 2 shows the location of areas proposed for revegetation.

- *Action 2. All areas of the reserve that are not required for open spaces should be revegetated with appropriate, locally occurring native plant species. These areas are marked on figure 2.*

This concept plan recommends the establishment of both lawn areas and parkland cleared areas (figure 2). Lawn areas have been sited where there are existing maintained lawns (immediately upstream of Naturaliste Terrace), or where there are thick infestations of kikuyu grass that could easily be turned into lawns.

- *Action 11. Lawn and parkland cleared areas should be established in the areas shown on figure 2.*
- *Action 12. Parkland cleared areas should have the understorey slashed during spring and autumn each year.*
- *Action 13. Areas set aside for open space should have successive plantings of peppermint and blackbutt trees to ensure a continuation of the tree canopy into the future.*

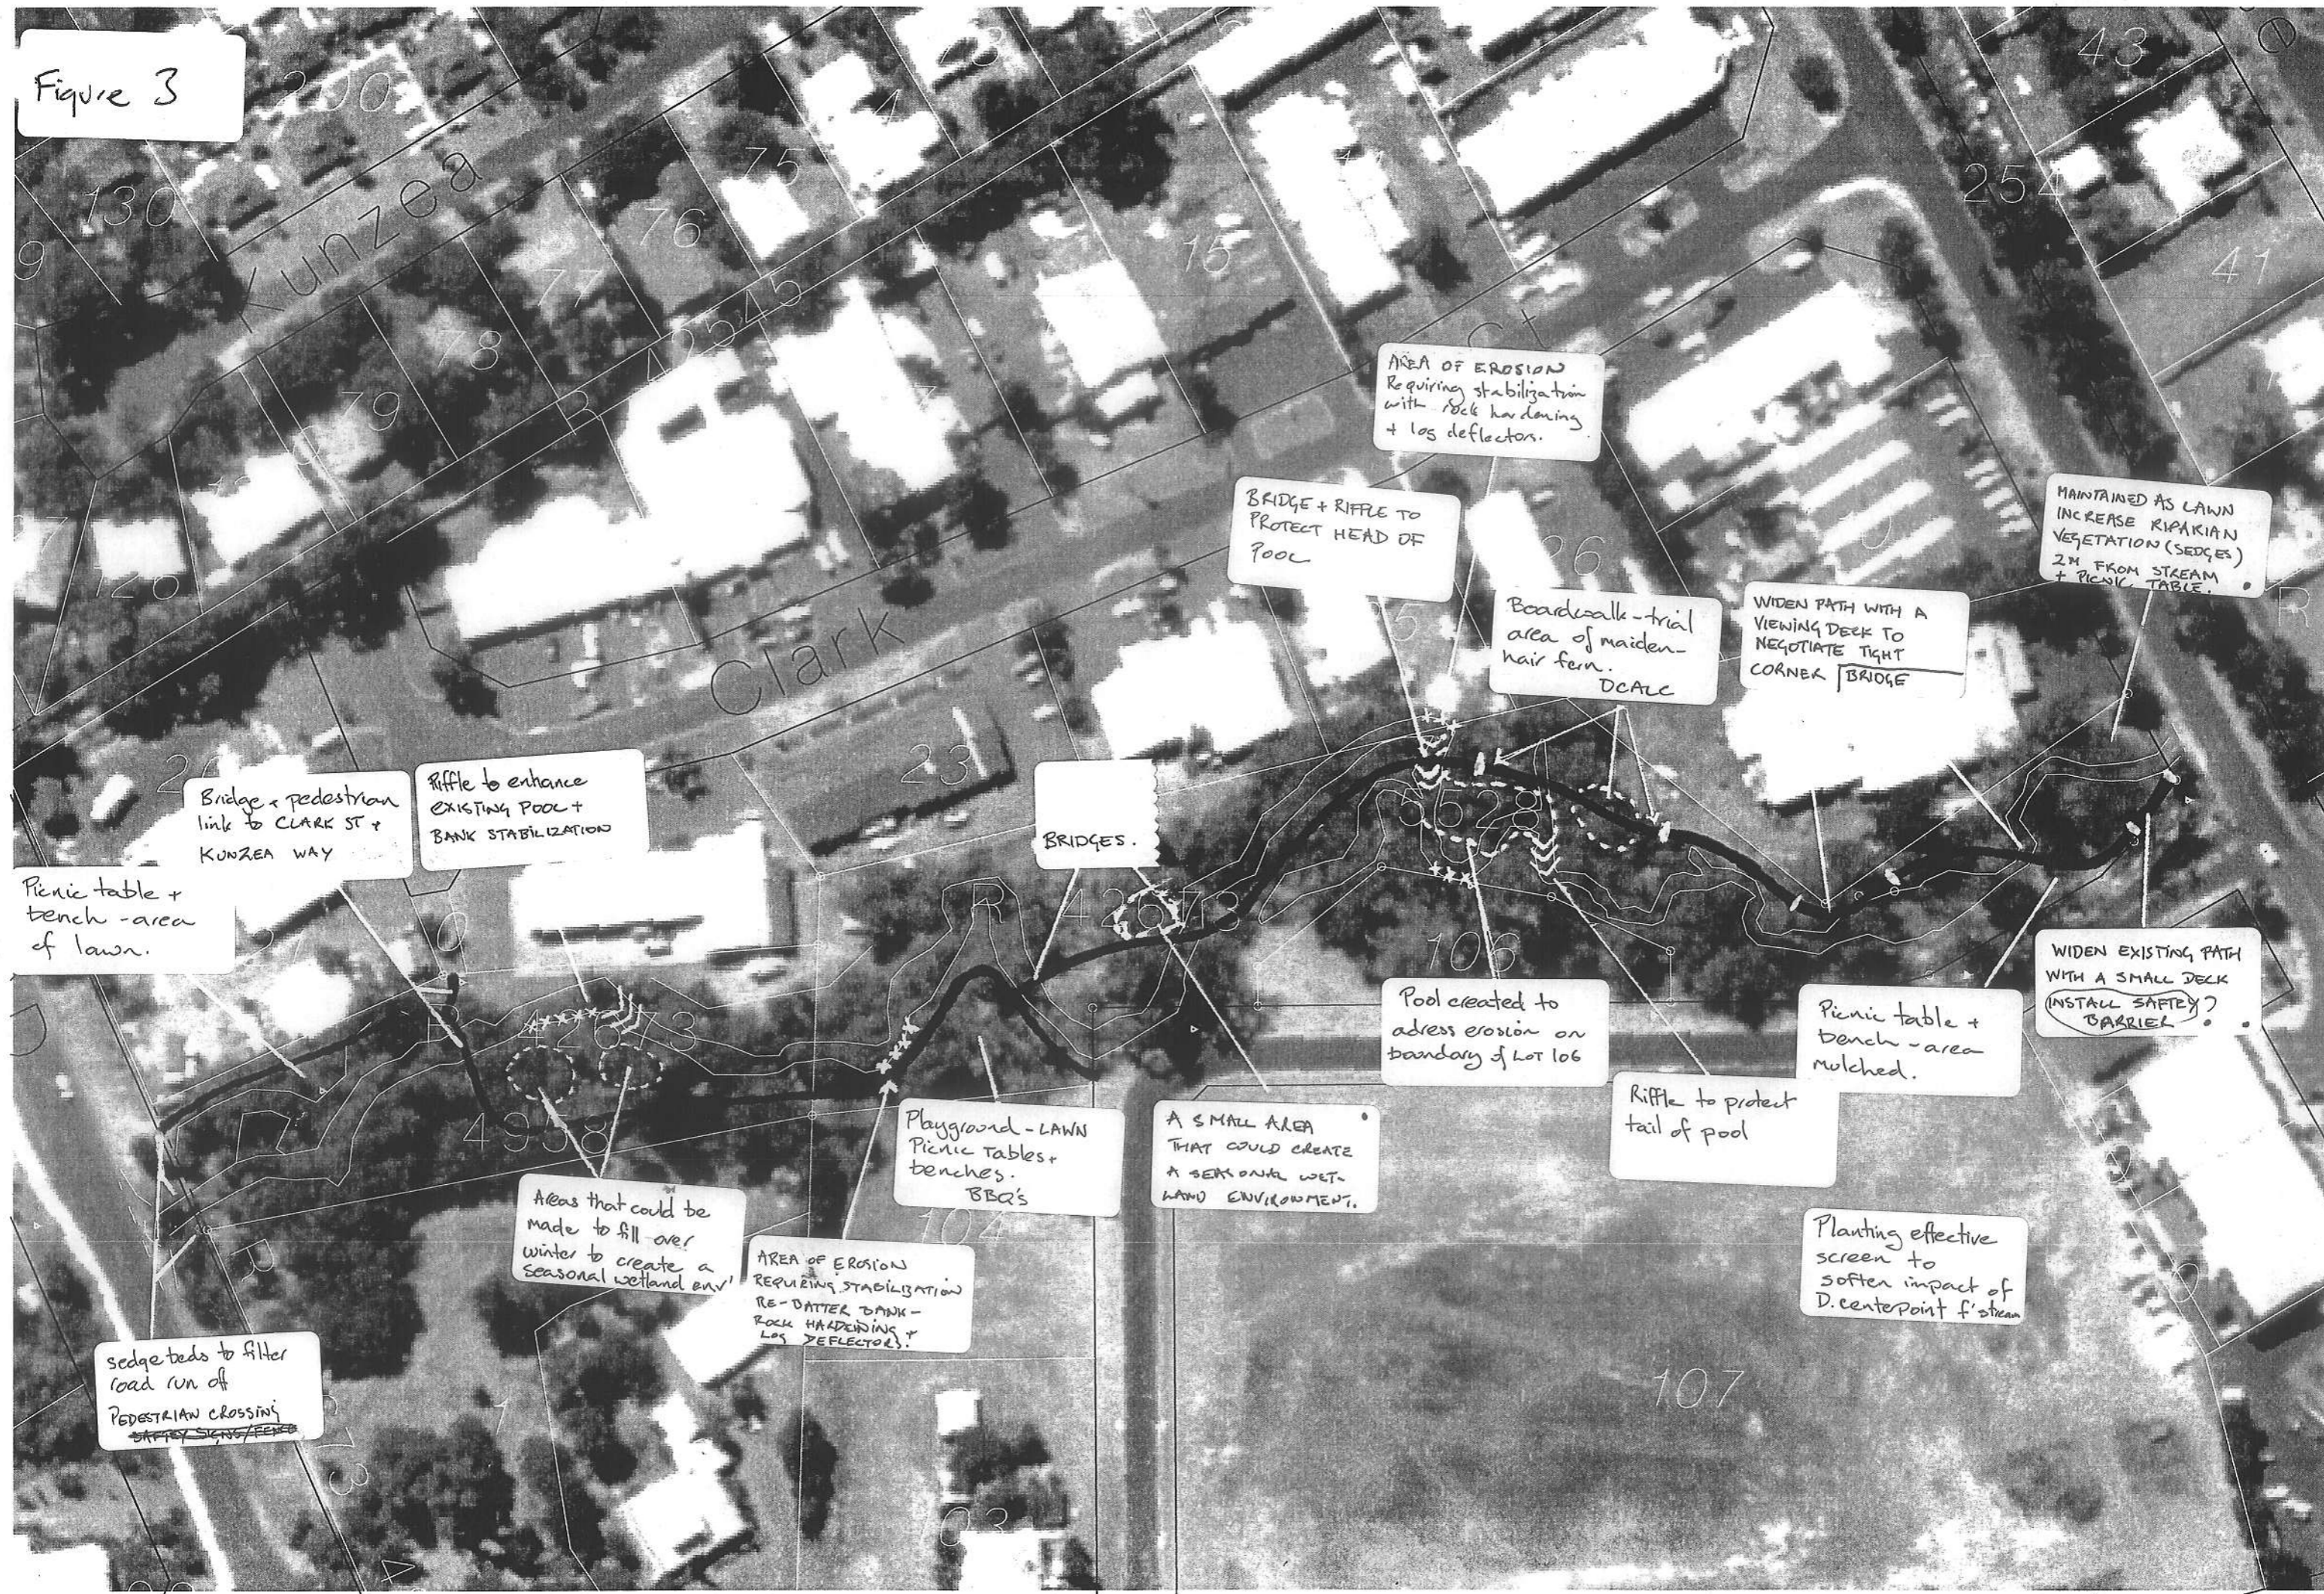
Figure 3

DCALC have requested that a shady area be set aside to trial revegetation of the native maidenhair fern (*Adiantum aethiopicum*). This area is shown on figure 3.

- *Action 7. Efforts should be made to obtain the three species of sword sedge recommended for use within the reserve, either from commercial or community nurseries (The Geographe Community Landcare Nursery or the Leschenault Community Nursery), or from development sites where they are being removed.*
- *Action 8. Where possible, local provenance seed stock should be used for all revegetation within the reserve.*
- *Action 9. Local provenance blackbutt and flooded gum seeds held by the Geographe Community Landcare Nursery should be used within the reserve if possible.*
- *Action 10. DCALC should trial revegetation of the native maidenhair fern in a shady area near the proposed boardwalk (shown on figure 3).*
