Lower Vasse River, Busselton

Acid Sulfate Soil and Dewatering Management Plan

**Prepared for
City of Busselton**

February 2022

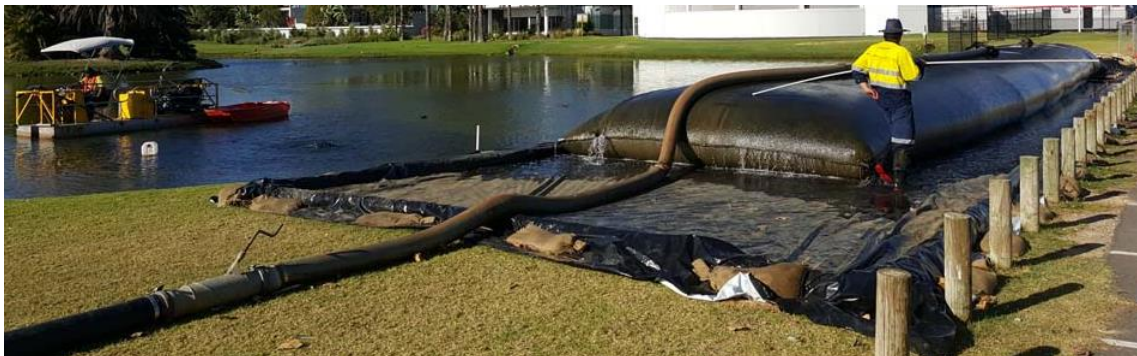
Image 1: Example Layout GeoPro™ desludging tubes (for information only)

A dredging contractor will remove the accumulated sediment from the LVR using a GeoPro™ Microdredge with a horizontal auger. The dredged sediments will be pumped into GeoPro™ desludging tubes (Image 1), located within an onshore lined and bunded laydown area. The sediments will be retained within the tubes while the dewatering effluent (return water) will be directed back to the river via a gravity fed channel (Image 2) or contained within a sump and pumped back to the river. The sediment tubes will continue to dewater for a further few weeks upon completion of dredging. Disposal of the dewatered dredged material will occur post analysis for contamination potential, with the preferred option being to treat the sediment and use as soil nourishment for public open space, or secondarily for use as day cover at the City of Busselton Waste Facility.

- The Geo-tubes will be set up on a lined and impermeable laydown area, so that infiltration of return water to ground is avoided. The size and installation of the Geo-tube laydown area will be determined by the Dredging Contractor.

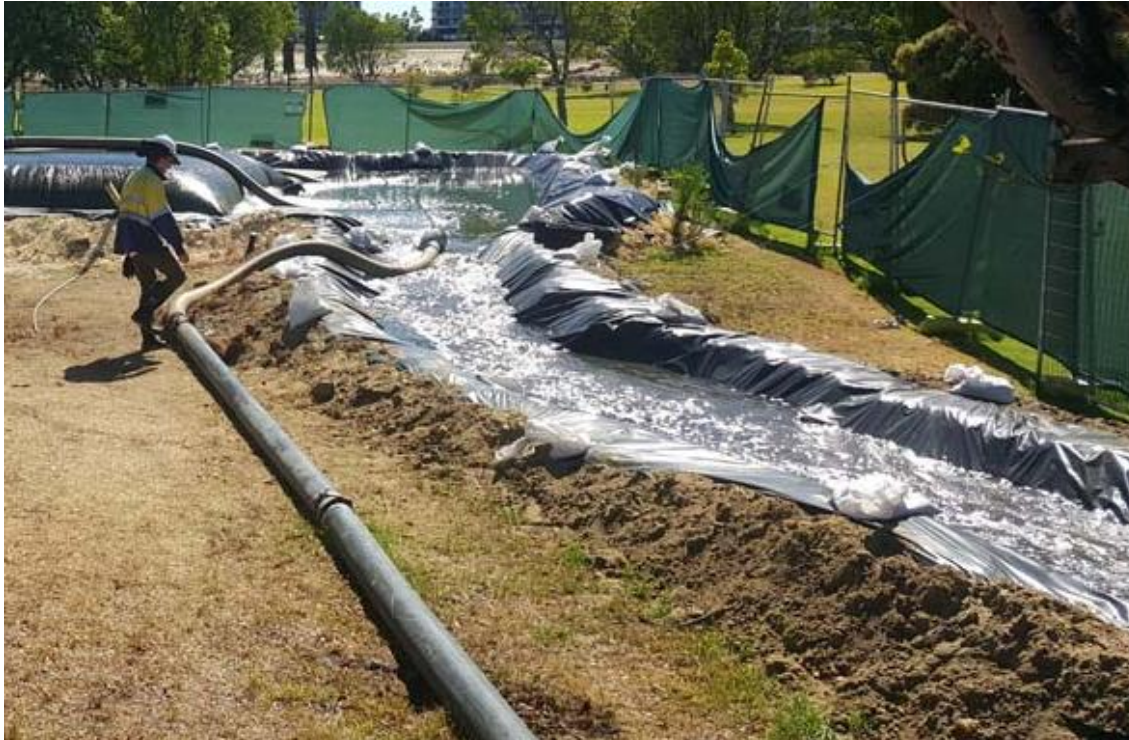
Image 2: Example return water channel (for information only)

- The return water channel will be set up from the Geo-Tubes to the river ensuring that the channel is of sufficient length to facilitate denitrification prior to re-entry to the LVR. The aim of this is to reduce (denitrify) the bioavailable nutrients through oxygenation and biodegradation to minimise the potential for these additional nutrients to adversely impact the water quality of the receiving body and potentially cause undesirable side effects, such as algal blooms.

- Following the completion of dredging, return water will continue to flow back to the river until the flow diminishes and can be allowed to infiltrate to ground beneath the tube laydown area.

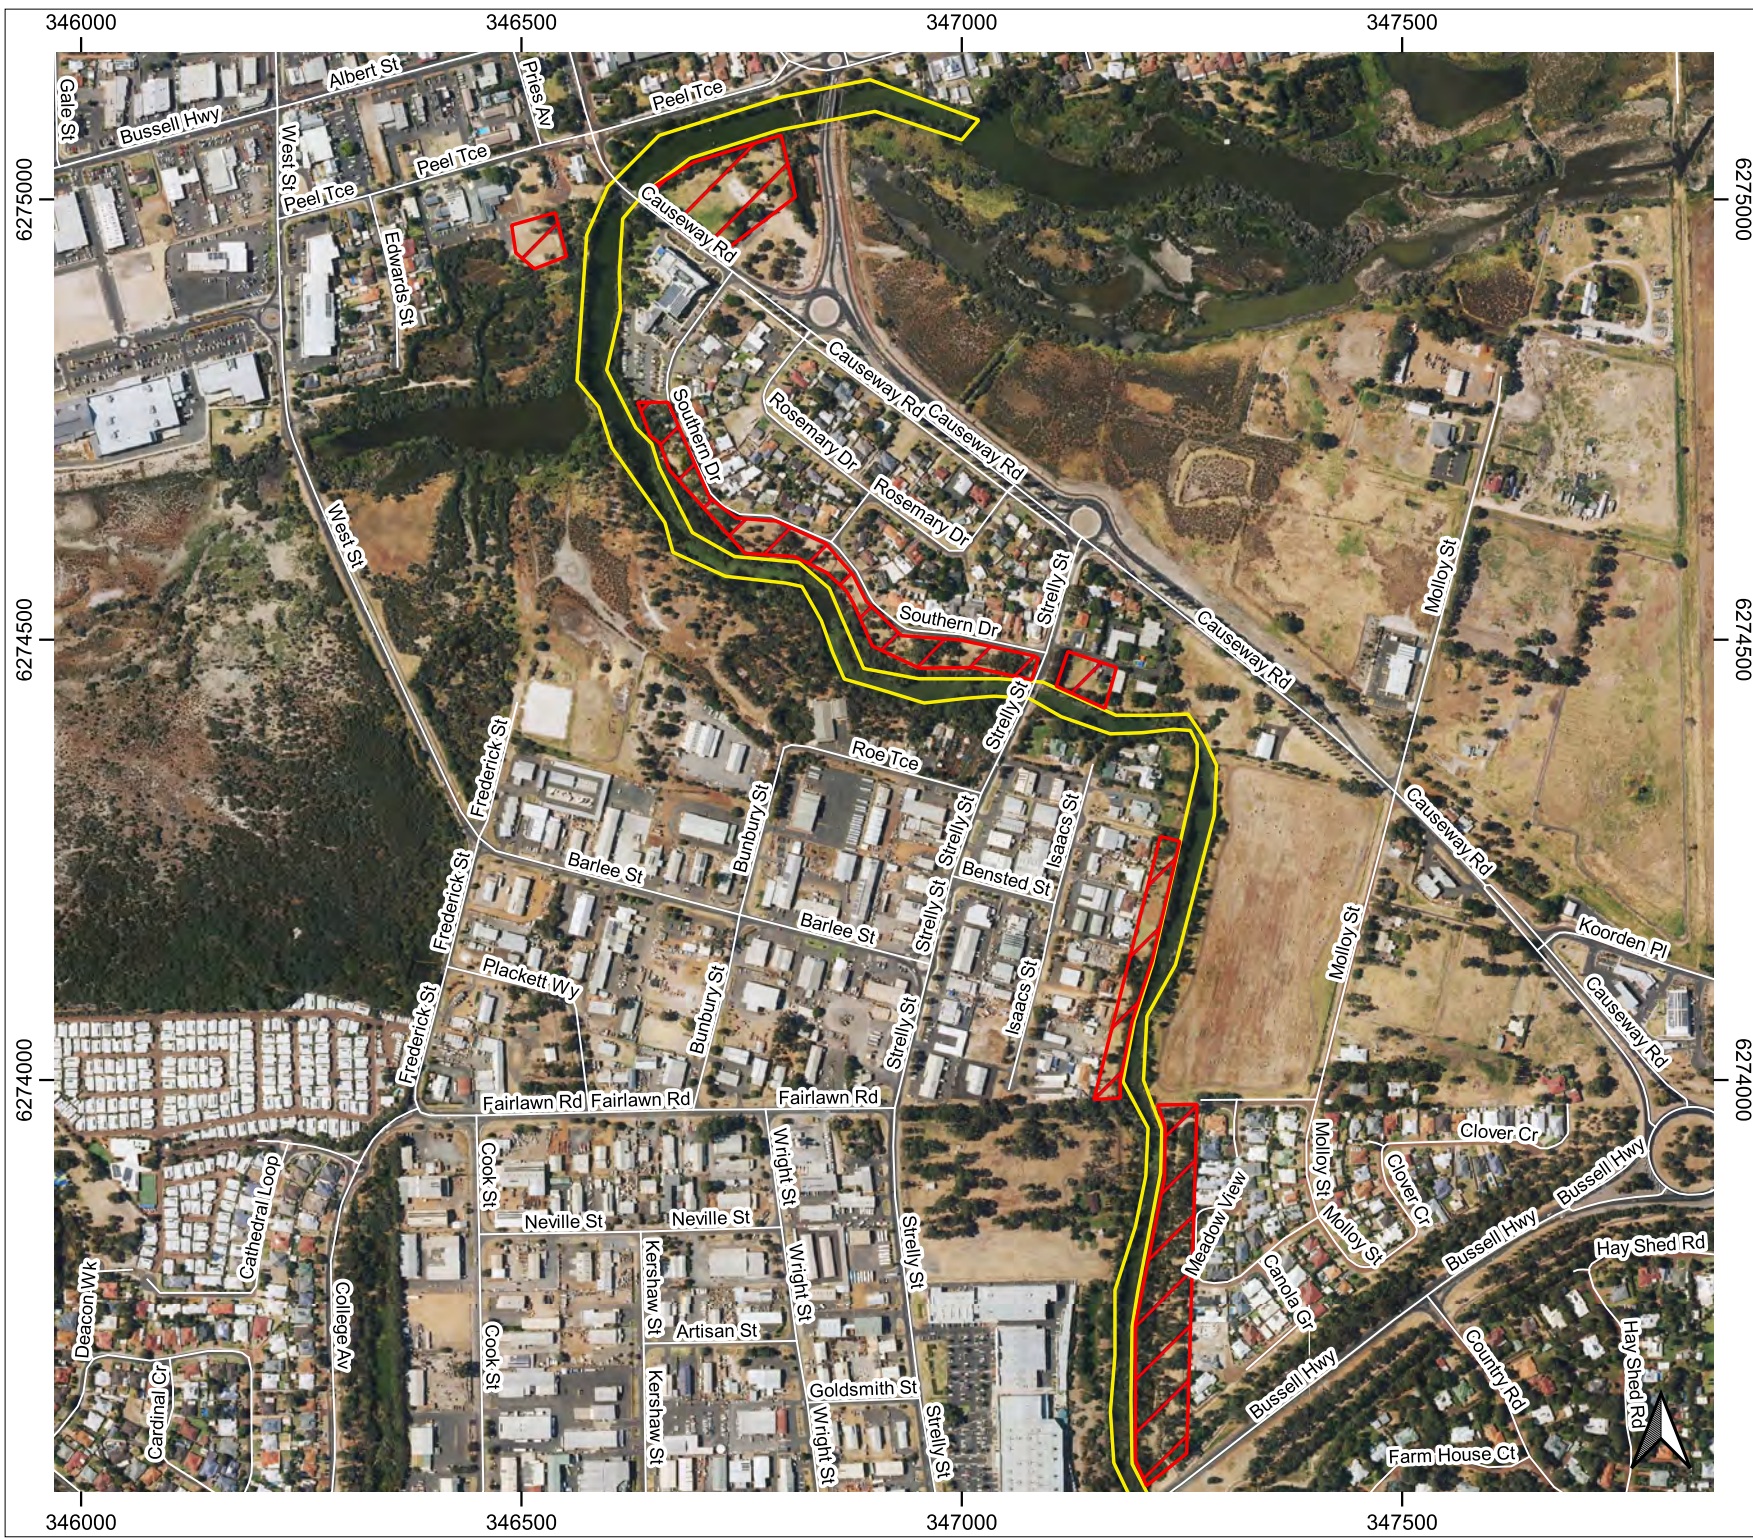
Figure 1
Site Location

- Development Footprint
- Proposed Dredge Area
- Proposed Laydown Areas for the temporary storage of Geomembrane bags

- Advancement of three (3) sediment cores at four (4) sampling locations (LVR-CS1/CS3-S1 to LVR-CS1/CS3-S4) with two (2) samples collected downstream of Cammilleri Street, and two (2) samples between Cammilleri Street and Bussell Hwy (**Figure 3**)

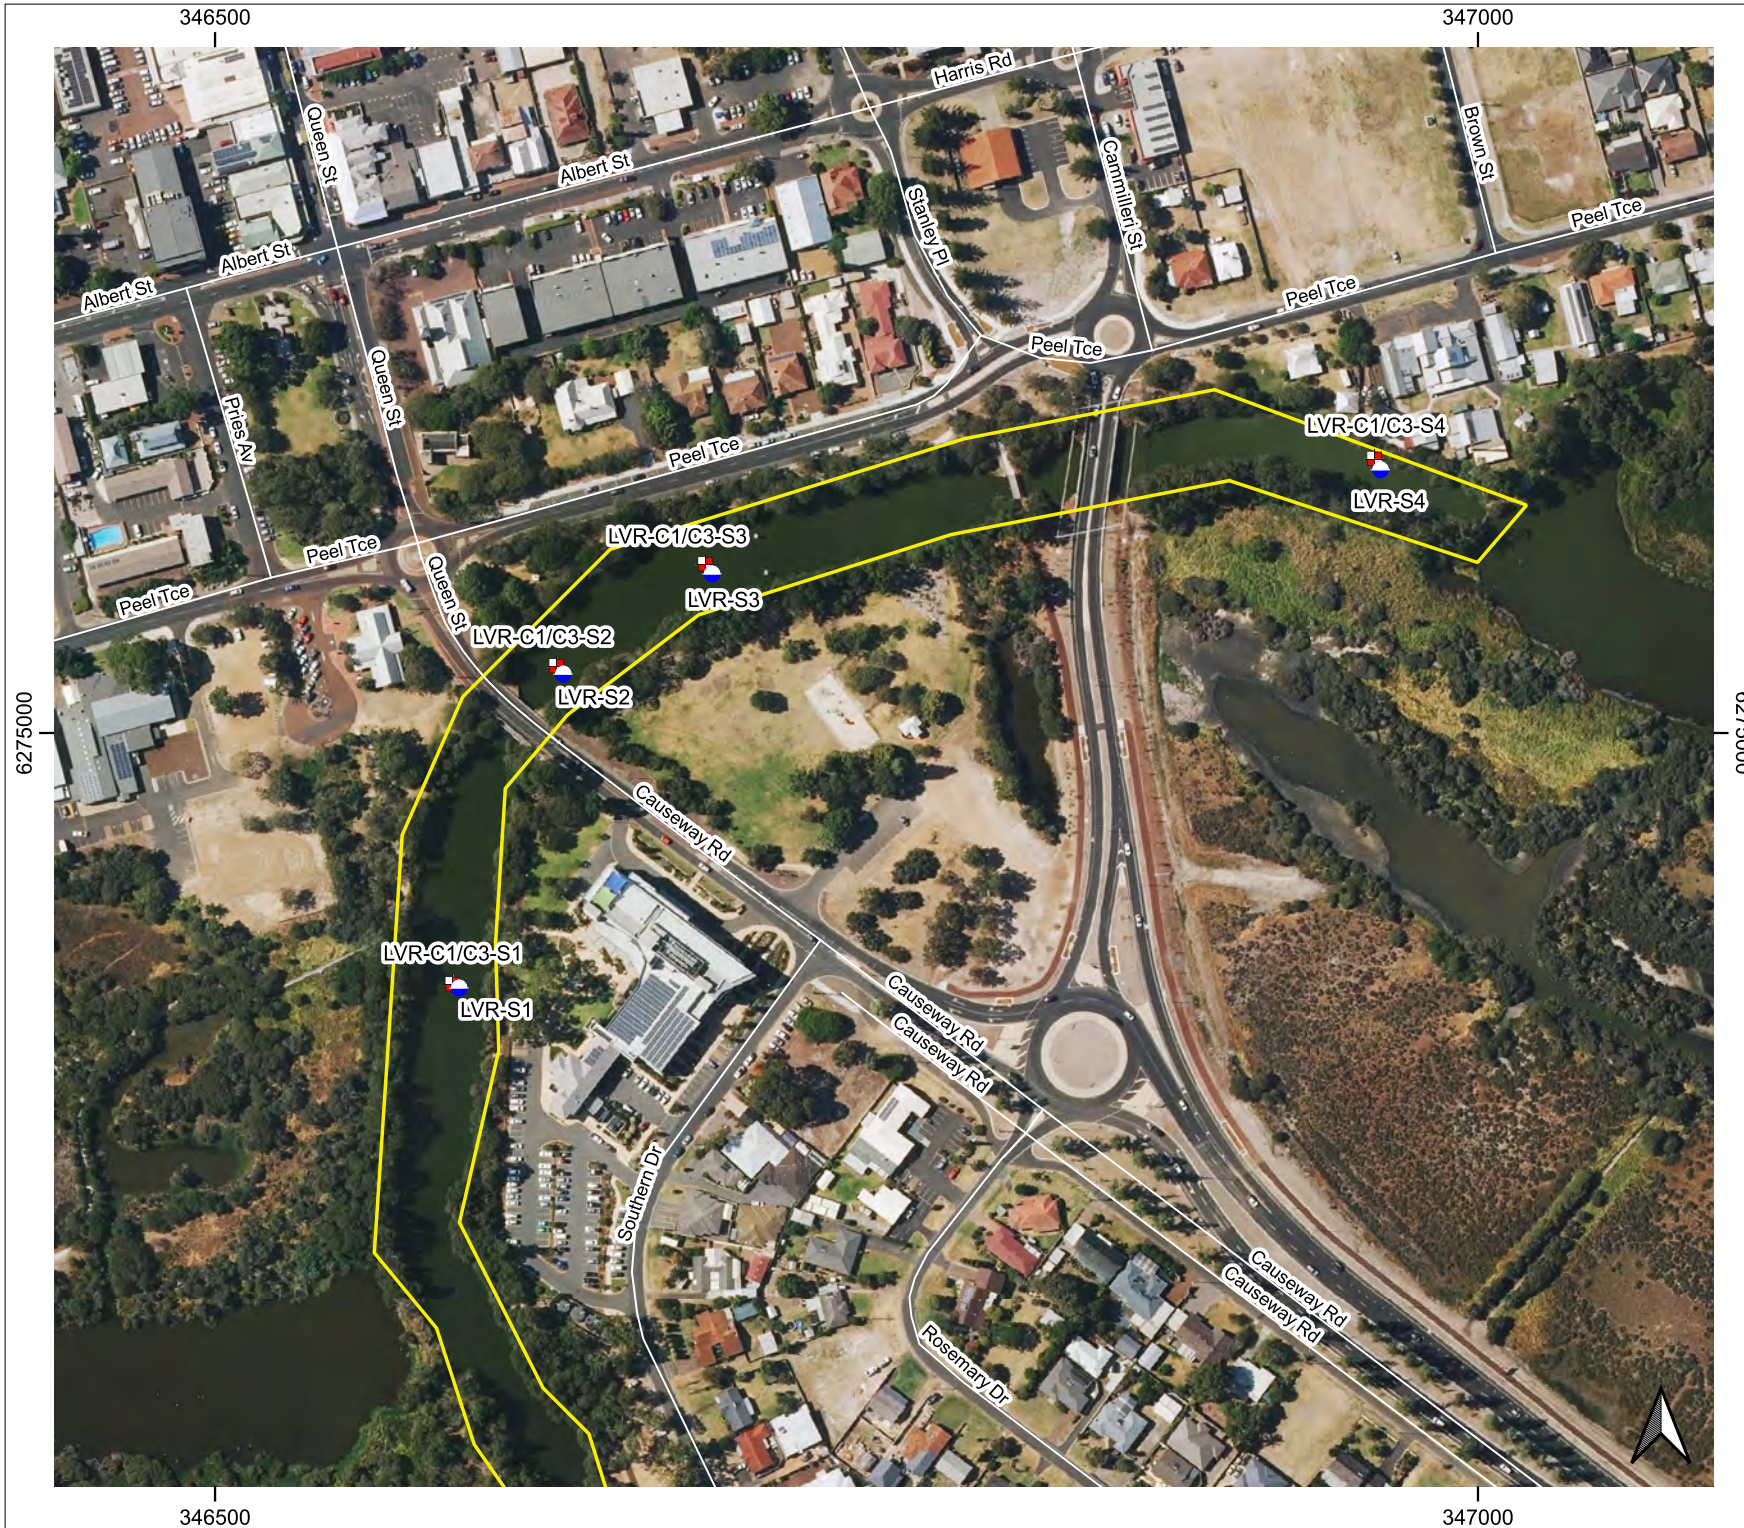
Proposed Dredge Area

Table 2 summarises the distribution of the sediment sampling locations collected for ASS purposes and the depth of collected samples. The location of the sampling location is presented on **Figure 3**.

Sediment samples (LVR-S1 to LVR-S4) were collected from the same four (4) sampling locations as the ASS sampling locations (**Figure 3**).

Four (4) surface water samples (LVR-S1 to LVR-S4) and four (4) elutriate samples (LVR-S1 to LVR-S4) were collected from the same four (4) sampling locations as the ASS and sediment sampling locations (**Figure 3**).
